GM Bulletin No.: 14481

SUBJECT: Service Update for Inventory Vehicles Only

Possible Loose Spark Plug Wires

MODELS: 2014 Chevrolet Corvette and Silverado LD

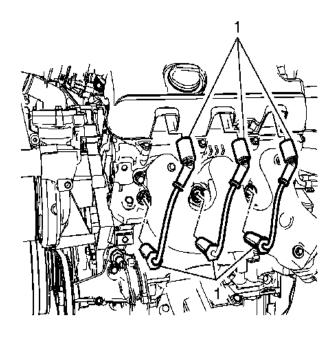
3995409

Sierra / Silverado Spark Plug Wire attachment boots (1).

1. Check all spark plug wires for loose connections at coil and plug. Pull and reseat wires at both ends. Refer to *Spark Plug Wire Replacement* in SI.
