Program Bulletin

CUSTOMER SATISFACTION PROGRAM

SUBJECT: Untreated Rivets and Poor Paint Finish on Underside of Hood

**MODELS: 2014 Buick Verano
2014 Chevrolet Sonic**

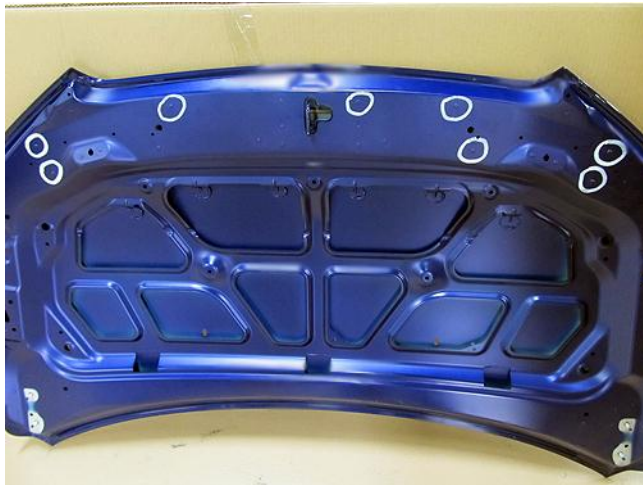
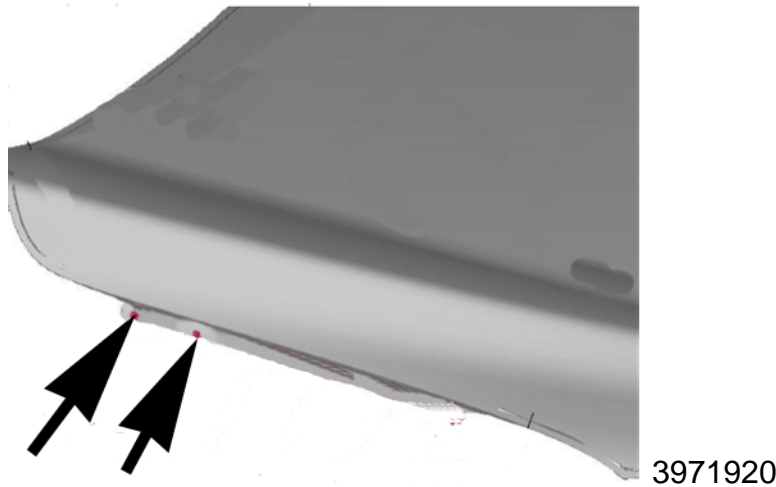
Sonic Rivet Locations

There are 10 rivet repair locations on the Sonic hood. 8 across the front and 2 at the right rear corner. Use the following graphics to insure all 10 locations have rivets. If any rivets are missing, use the Rivet Installation steps below to install the necessary rivets. If all of the locations have a rivet installed, proceed to the Finish Repair and Corrosion Protection Steps.

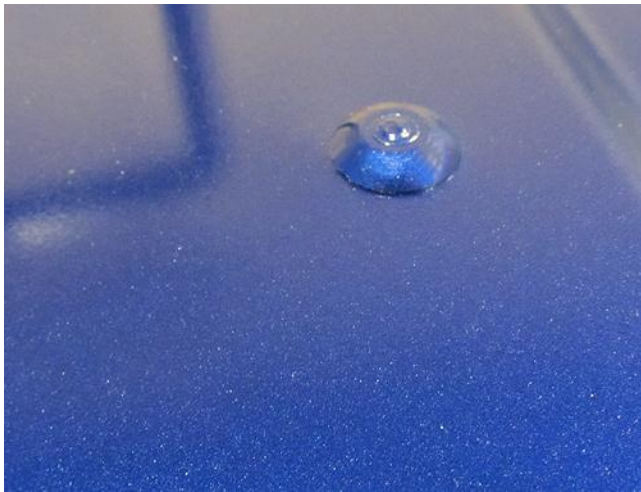
3971949

16. Inspect the appearance of the paint repair in the replacement rivet areas. These areas will need to be refinished.
17. Sand off the brush applied touch up paint as required. If any corrosion is present, repair as necessary before paint.
