SUBJECT: Service Update for Inventory and Customer Vehicles
Hood Latch Striker Weld
Expires with Base Warranty

MODELS: 2015 Cadillac ATS

Subject: 14545 – Service Update Bulletin
Hood Latch Striker Weld

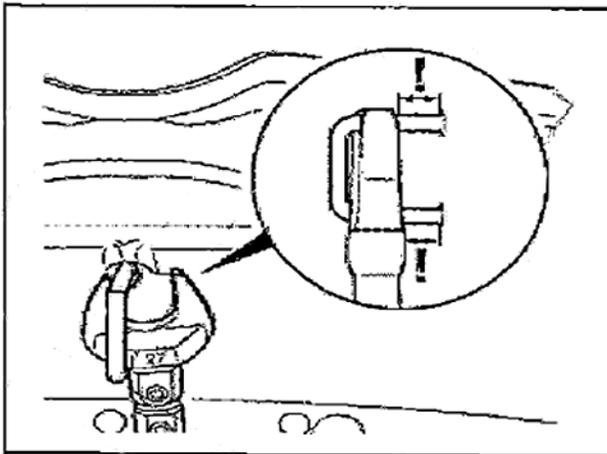
3975743

Note: Use of a 1" crows foot wrench is necessary to check the torque.

2. Position the torque wrench to the lowest position of the hood striker, as shown above.

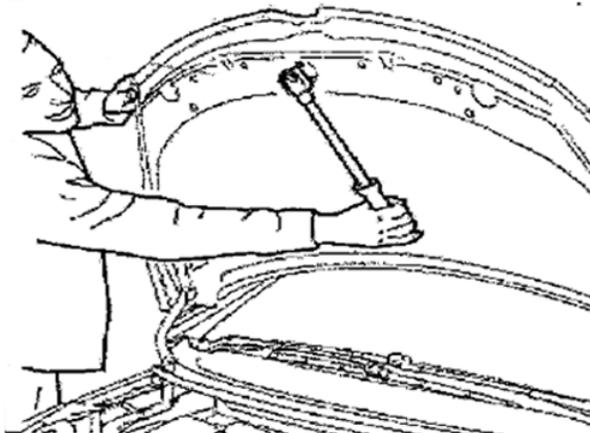
3975744

3. Apply 72 Nm (53 lb ft.) of torque to the striker while holding the hood with the opposite hand.

- Repeat the same test in the opposite direction.

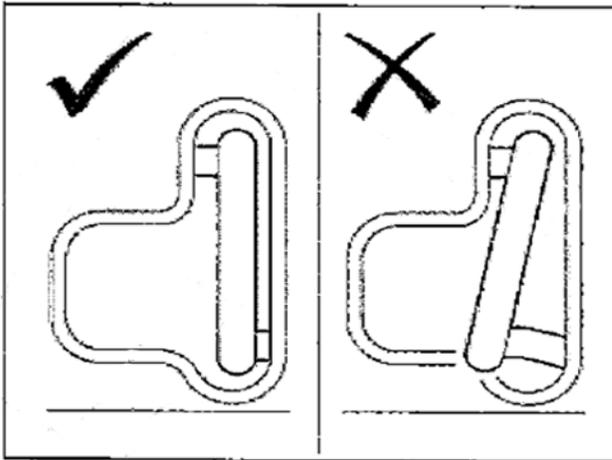
3975749

- Verify that the striker is not loose or bent, as shown in the example above.
 - If the hood striker does NOT show any looseness or bending, no further action is required; just verify the hood closes properly.
 - If the hood striker DOES show looseness or bending, continue on to the *Hood Replacement Procedure* below.
