**SERVICE INFORMATION**

**APPLICABILITY:** 2013-14MY BRZ

**NUMBER:** 07-86-14

**SUBJECT:** Vibration Sound from High-Mount Stop Lamp Assembly

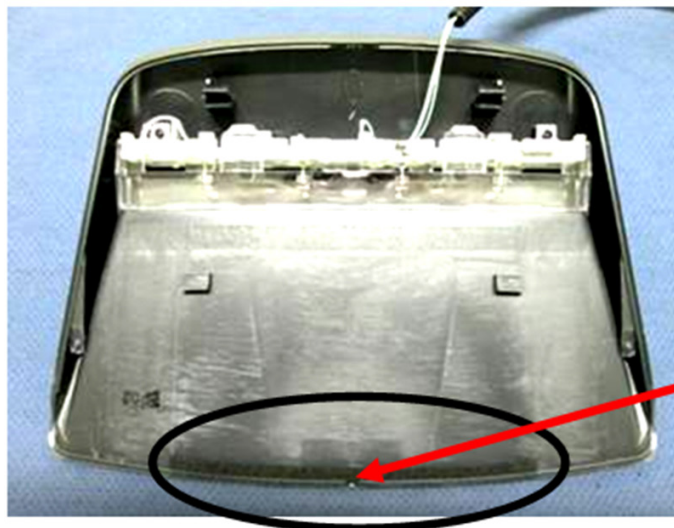
This bulletin announces the availability of a new high-mount stop lamp assembly designed to address a customer concern of a vibration-type sound which may be heard while driving. Non-woven fabric material was added to eliminate the sound.

**Addition of non-woven fabric**

PART NAME:	NEW PART NUMBER
STOP LP AY HI MTG	84701CA002VH
