Recall Bulletin

PRODUCT EMISSION RECALL

SUBJECT: Oxygen Sensor Fracture

MODELS: 2011-2013 Chevrolet Express
2011-2013 GMC Savana
Cutaway Equipped with Gasoline or Liquefied Petroleum Gas (LPG) Fuel Engines

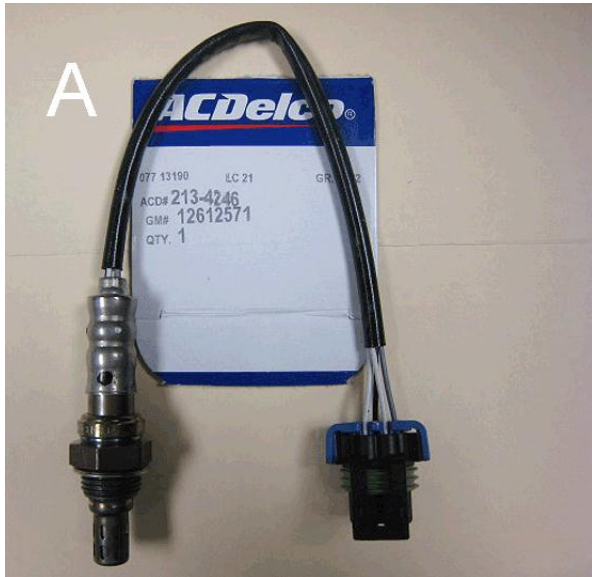
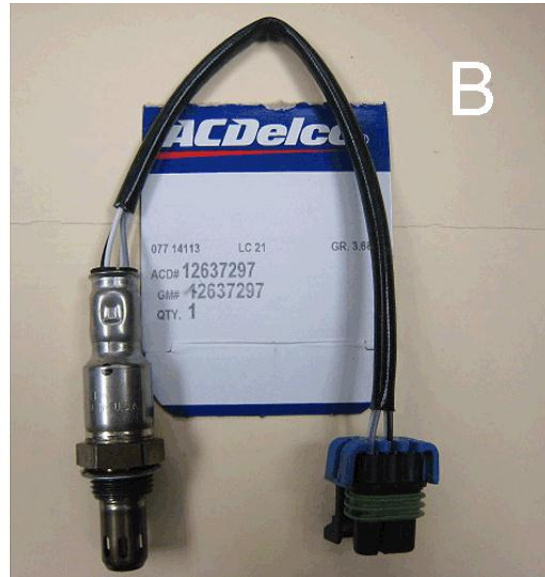
3961549

(A) 2011 through early 2013 OE production first design male connector. Replace the part with a second design part with a male connector, P/N 12637297. (B) 2011 through 2013 second design service part, P/N12637297. Do NOT replace this part unless the part has failed. If the part has failed, replace the part with the second design part with a male connector, P/N 12637297.

3. Determine if a first design (A) or second design (B) heated oxygen sensor is installed using a light and mirror.
 - If a second design (B), P/N 12637297, P/N 12656071 heated oxygen sensor is currently installed, no further action is required. Lower the vehicle. Refer to *Lifting and Jacking the Vehicle* in SI.
 - If a first design (A), P/N 12612571, heated oxygen sensor is in place, remove the sensor and replace it with a second design heated oxygen sensor. Refer to *Heated Oxygen Sensor Replacement –Bank 2 Sensor 2* in SI and *Heated Oxygen Sensor Replacement –Bank 1 Sensor 2* in SI.

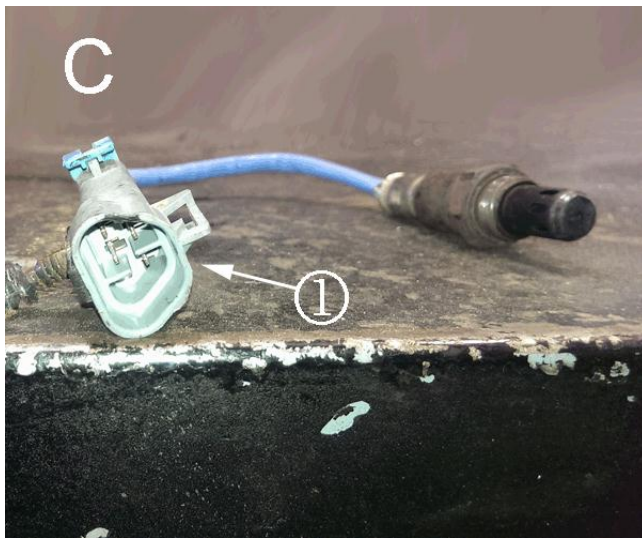
3961552

(C) This is the second design 2013 production sensor with the female plug (1). The sensor and plug change was made to indicate the new design. Do NOT replace this sensor, P/N12656071, unless the part has failed.
