Program Bulletin

CUSTOMER SATISFACTION PROGRAM

SUBJECT: Seat Mounted Side Impact Airbag Connector

MODELS: 2014 Chevrolet Silverado 1500
2014 GMC Sierra 1500

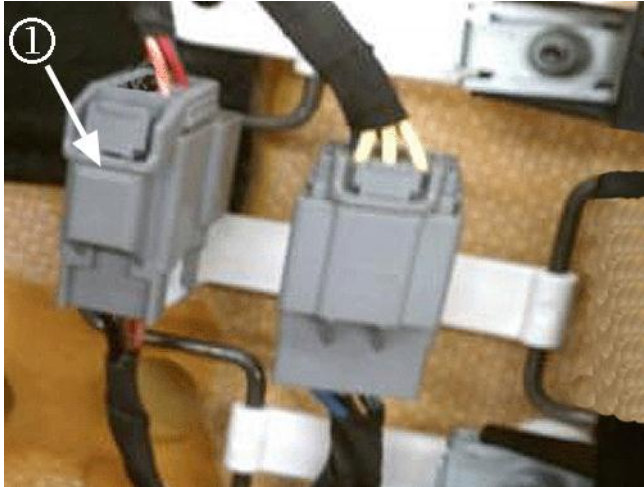
3957349

1. Starting on the passenger seat, locate the inboard grey SIAB harness connector (1) on the underside of the seat cushion.

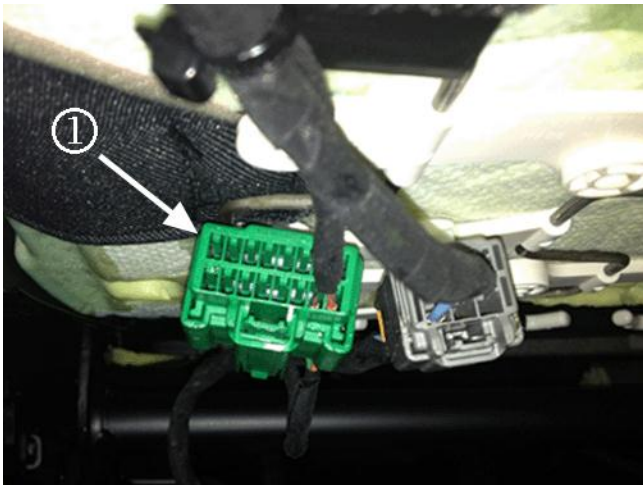
3957382

14. Moving to the driver seat, locate the outboard green SIAB harness connector (1) on the underside of the seat cushion.
