# Program Bulletin

## CUSTOMER SATISFACTION PROGRAM

**SUBJECT:** Passenger Airbag Status Indicator Illumination

**MODELS:** 2014 Cadillac CTS (VIN A)

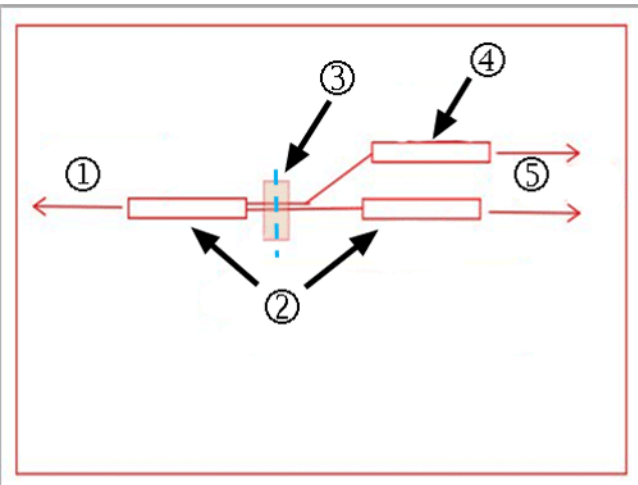
3902204

**Note:** The illustration above shows a representation of the completed splice.

- (1) To connector end
- (2) Circuit 539
- (3) Solder joint and splice clip
- (4) Circuit 1139
- (5) To bundle end

3. Working with the headliner side of the in-line, detach the harness connector push pin from the sheet metal, and pull the harness free from the retaining clips along the A-Pillar.
4. Carefully remove approximately 76 mm (3 in) of conduit and tape from the connector end of the harness.
