# Service Bulletin

**SUBJECT:** Service Update for Inventory and Customer Vehicles  
RESS Battery Coolant Level Low  
Expires with Base Warranty

**MODELS:** 2012-2013 Chevrolet Volt

Subject: 14114 – Service Update Bulletin  
RESS Battery Coolant Level Low

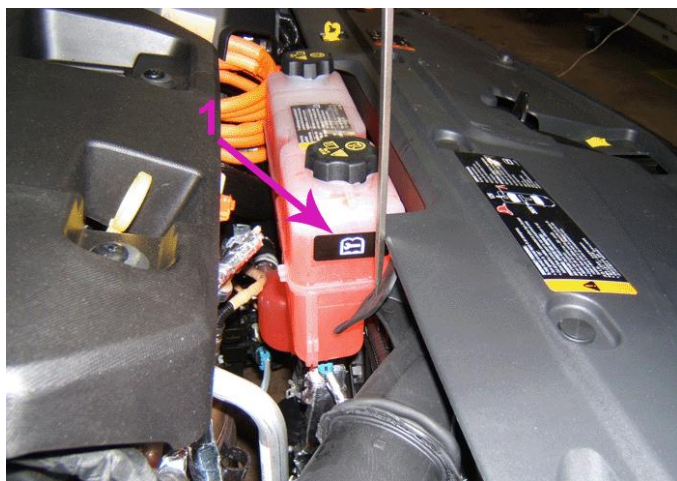
3672187

1. Visually inspect the coolant level in the HV battery surge tank and verify that the coolant level is *at the top of the label (1)* on the side of the surge tank.

2. Determine the surge tank coolant level.
  - If the HV battery surge tank coolant level is *at the top of the label (1)* on the side of the surge tank, no further action is required.
  - If the HV battery surge tank coolant level is *not at the top of the label (1)* on the side of the surge tank, refer to *Pressure Test Procedure* in this bulletin.
