# Program Bulletin

## CUSTOMER SATISFACTION PROGRAM

**SUBJECT:** Air Conditioning System Inoperative or Cools Intermittently

**MODELS:** 2013-2014 Chevrolet Spark

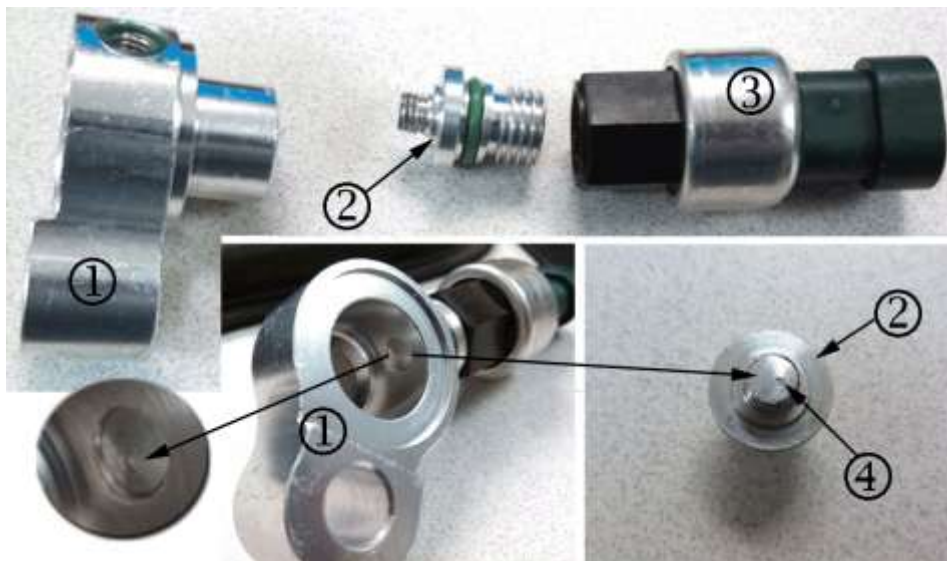
**A/C Refrigerant Filter Kit**

(1) Block Filter (2) Plug with 0.005 in Diameter Hole (3) Pressure Switch (4) 0.005 in Diameter Hole

**Note: Do NOT attempt to drill the 0.005 in diameter hole bigger.**

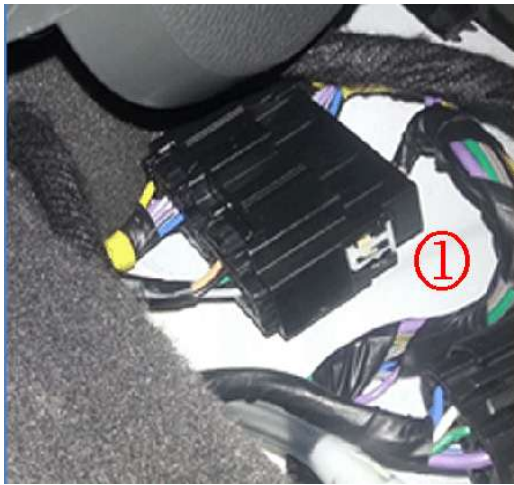
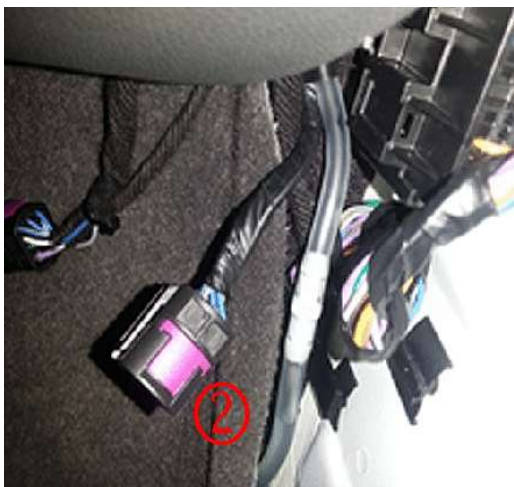
- (1) Inline Body Connector
- (2) IP Connector

8. Under the dash, disconnect the inline body connector and IP connector from the harness and disconnect the washer hose.
