CUSTOMER SATISFACTION PROGRAM

SUBJECT: Tail Lamp Gasket Seal

MODELS: 2014 Chevrolet Impala

Subject: 14047 - Customer Satisfaction Program
Tail Lamp Gasket Seal

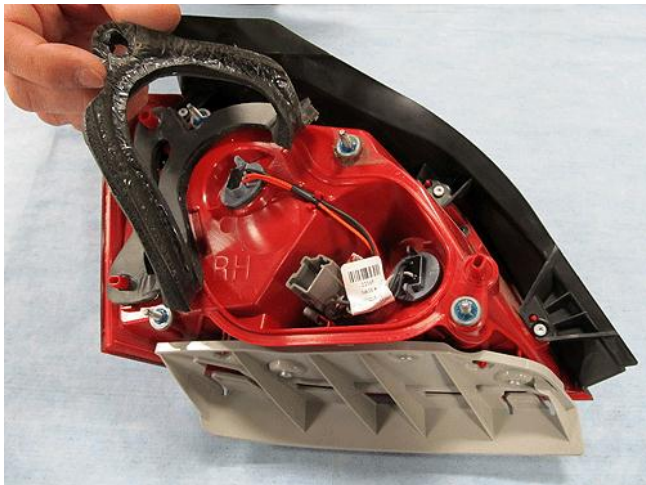
3649621

3. Place the tail lamp assembly on a soft work area to prevent damage to the outer lens area.

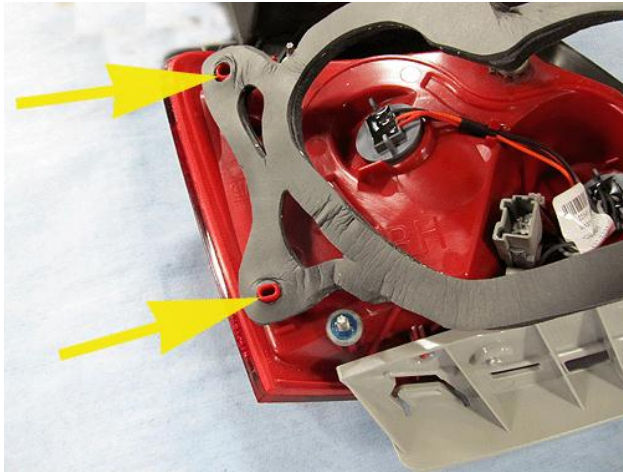
3649624

4. Slowly peel the seal away from the housing, using care to remove the adhesive from the housing. **Tip:** Removing the seal at a 45 degree angle while slightly stretching the rubber will remove most of the adhesive with the seal.

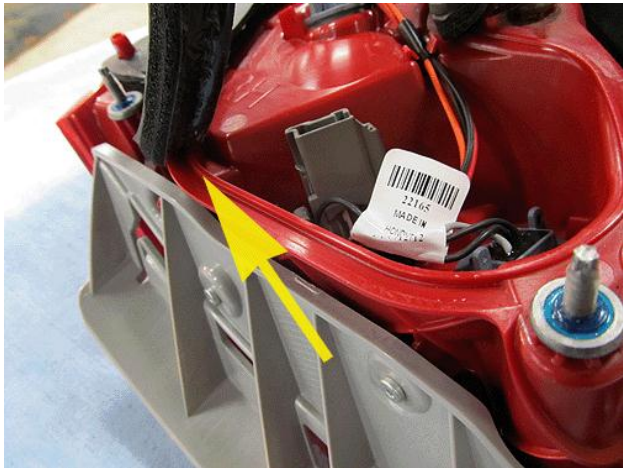
3649627

5. Clean any old adhesive from the tail lamp housing using a general purpose adhesive remover.
6. Start the new seal application by placing the two outer alignment pins through the holes on the seal. Ensure that the adhesive side of the seal is facing the tail lamp.

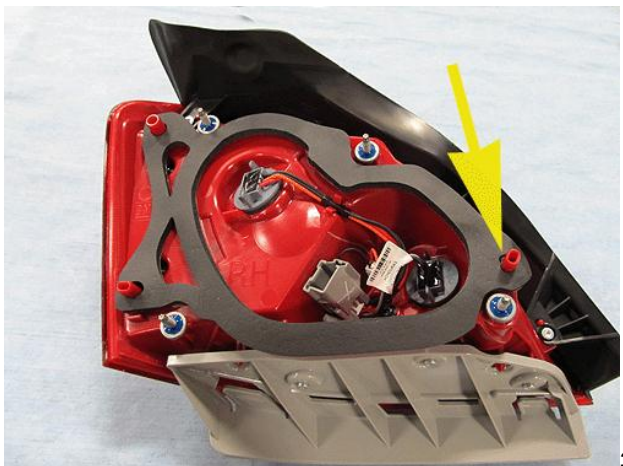
3649630

- 6.1 Install the seal, ensuring that it is centered on the compression ribs on the tail lamp housing as shown.
