Recall Bulletin

PRODUCT EMISSION RECALL

SUBJECT: Oxygen Sensor Fracture

MODELS: 2011-2013 Chevrolet Express
2011-2013 GMC Savana
Cutaway Equipped with Gasoline Engine

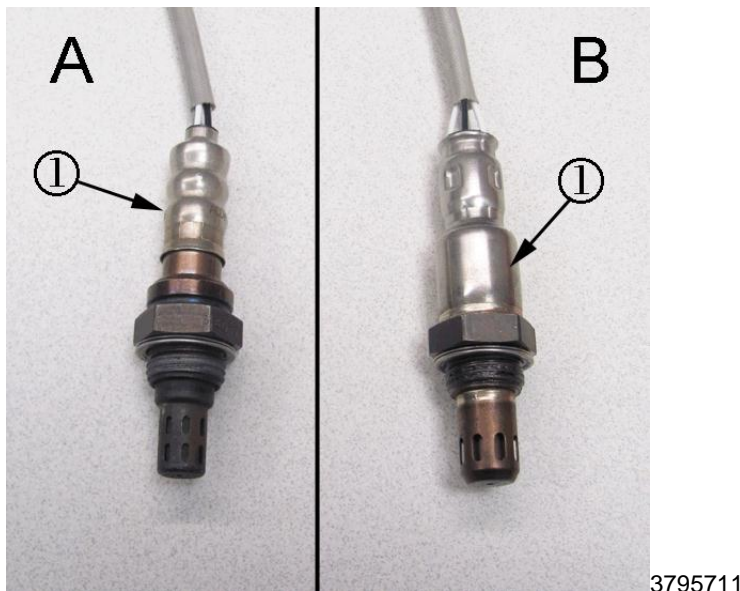
(A) First Design Heated Oxygen Sensor (B) Second Design Heated Oxygen Sensor (1) Location of Part Number

3. Determine if a first design (A) or second design (B) heated oxygen sensor is installed using a light and mirror.
 - If a second design (B), P/N 12637297, heated oxygen sensor is installed, no further action is required. Lower the vehicle. Refer to *Lifting and Jacking the Vehicle* in SI.
 - If a first design (A), P/N 12656071 or P/N 12612571, heated oxygen sensor is installed, remove the sensor and replace it with a second design heated oxygen sensor. Refer to *Heated Oxygen Sensor Replacement – Bank 2 Sensor 1* in SI and *Heated Oxygen Sensor Replacement – Bank 2 Sensor 2* in SI.
