Program Bulletin

CUSTOMER SATISFACTION PROGRAM

SUBJECT: Air Conditioning System Inoperative or Cools Intermittently

MODELS: 2013-2014 Chevrolet Spark

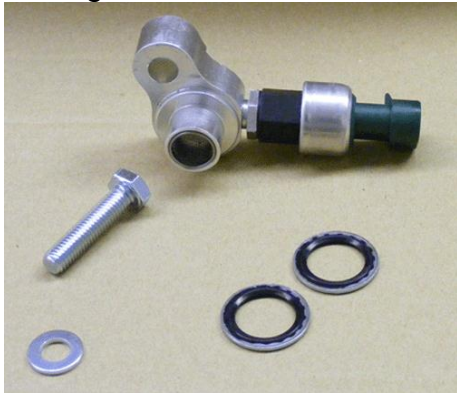
3782696

A/C Refrigerant Filter Kit

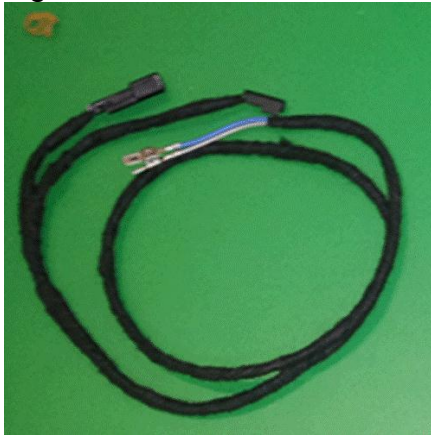
3782704

Wiring Harness Kit

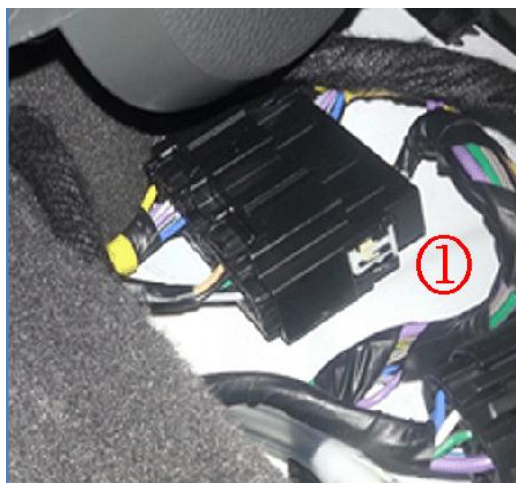
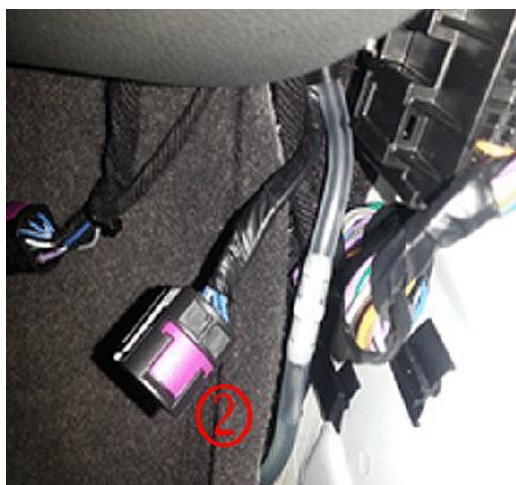
- (1) Inline Body Connector
- (2) IP Connector

8. Under the dash, disconnect the inline body connector and IP connector from the harness and disconnect the washer hose.
