SERVICE BULLETIN

APPLICABILITY: 2015MY Legacy Models

NUMBER: 09-58-14

SUBJECT: Procedure to Improve Fit and Operation of the Fuel Filler Door (Flap)

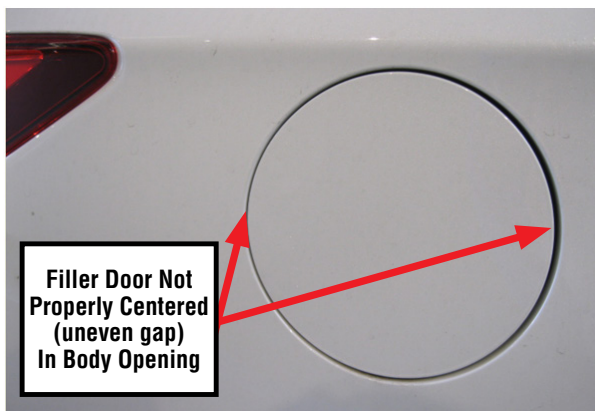
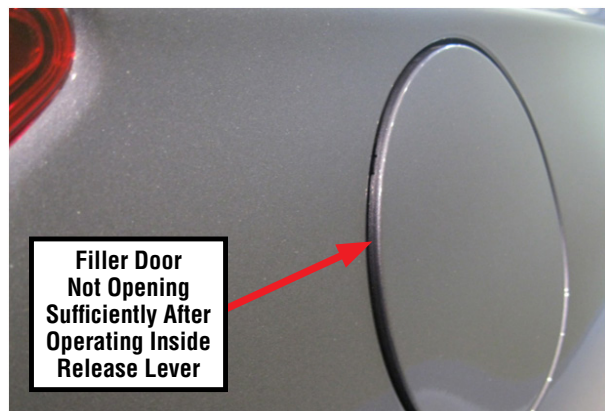
This bulletin provides a service procedure to improve the fit of the fuel filler door to the body. The procedure will also address customer concerns of the fuel door not opening properly when using the inside release lever. Photos of each condition are shown below.

A countermeasure to adjust the positioning of the fuel filler door assembly was been incorporated into production starting with VIN **F3016878**.
