SERVICE BULLETIN

APPLICABILITY: 2015MY Legacy and Outback Models

NUMBER: 15-177-14

SUBJECT: New “Gen 2” Fujitsu Ten (F10) SD Card Audio / Navigation System Operating Tips

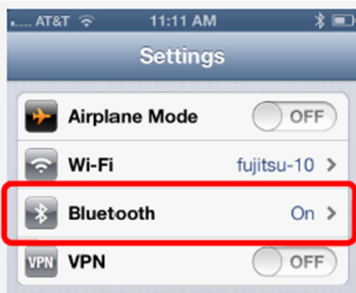
CONDITION #1: Cannot receive incoming text messages on the head unit when using an iPhone.

“Show Notifications” is not activated in the iPhone’s Bluetooth Settings menu.

2. From the Settings menu, select “Bluetooth”.

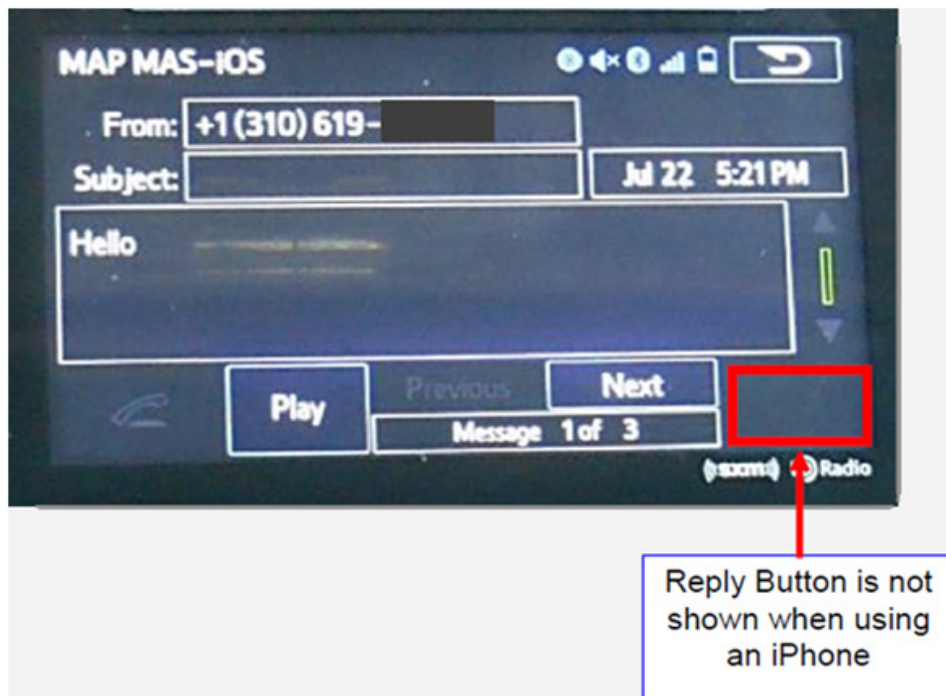
CONDITION #2: Unable to reply to received text messages from the head unit when using an iPhone.

The iPhone provides the Mail-accessing (Text Message) feature via the Bluetooth profile MAP (Mail Access Profile). The MAP profile does not always allow the user to read and reply (both) to text message content from the smartphone connected to the head unit. As per Apple specifications, the iPhone’s MAP does not support the reply function.

Inform the customer when their iPhone is paired to the head unit, the head unit will be able to display and read aloud the incoming text messages. However, the “Reply” message function will not be available.

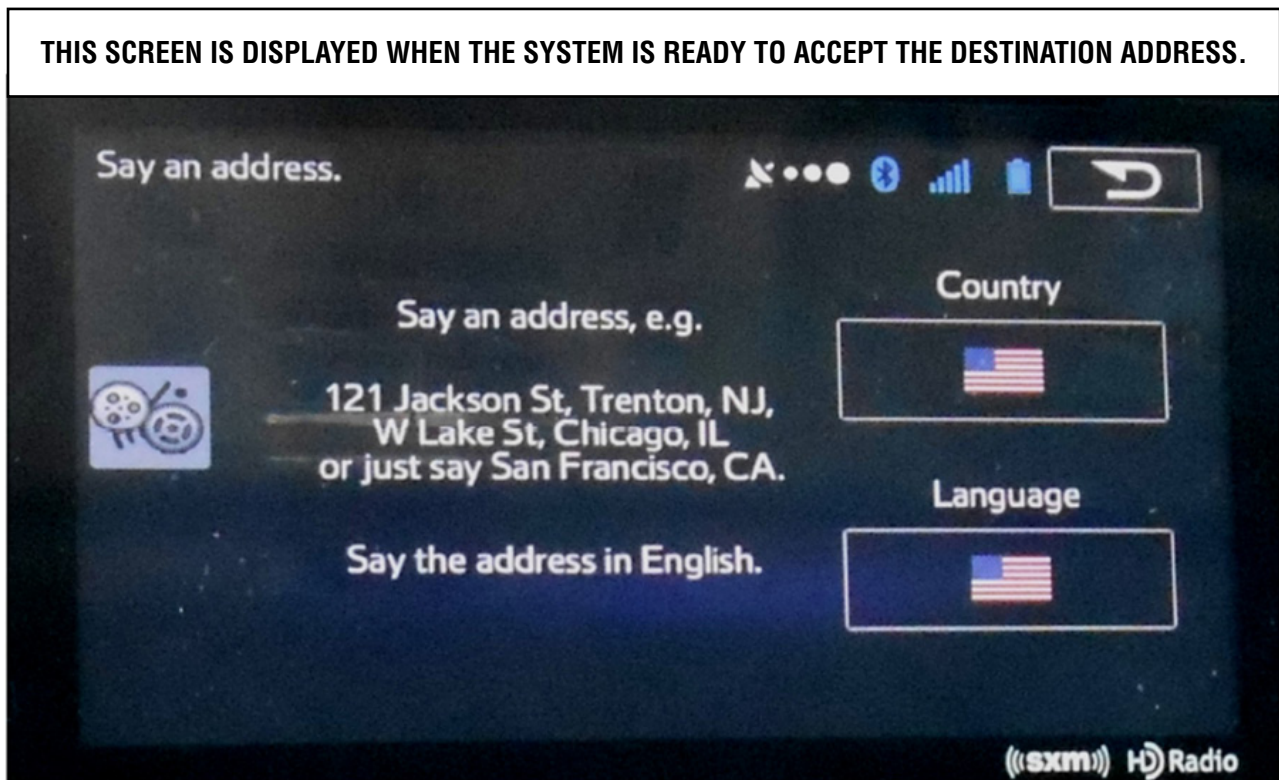
CONDITION #3: Unable to set up the “Destination Address” using voice command.

Voice commands are not spoken with the correct pause, timing or cadence between “House Number”, “Street Name”, “City Name” and “State” which the head unit can understand.

Say the Destination Address with the correct pause, timing or cadence as shown in the example. Below are examples of incorrect and correct commands:

Incorrect command: 121[pause] Jackson [pause] Street [pause] Trenton [pause] NJ

Correct command: 121JacksonStreetTrentonNJ

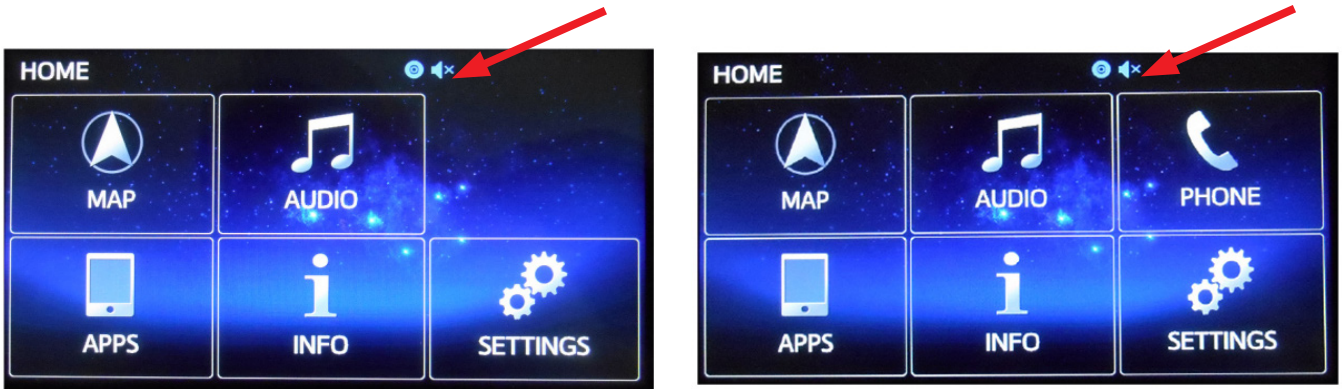
CONDITION: #5: A “Phone” button is not displayed on the HOME screen.

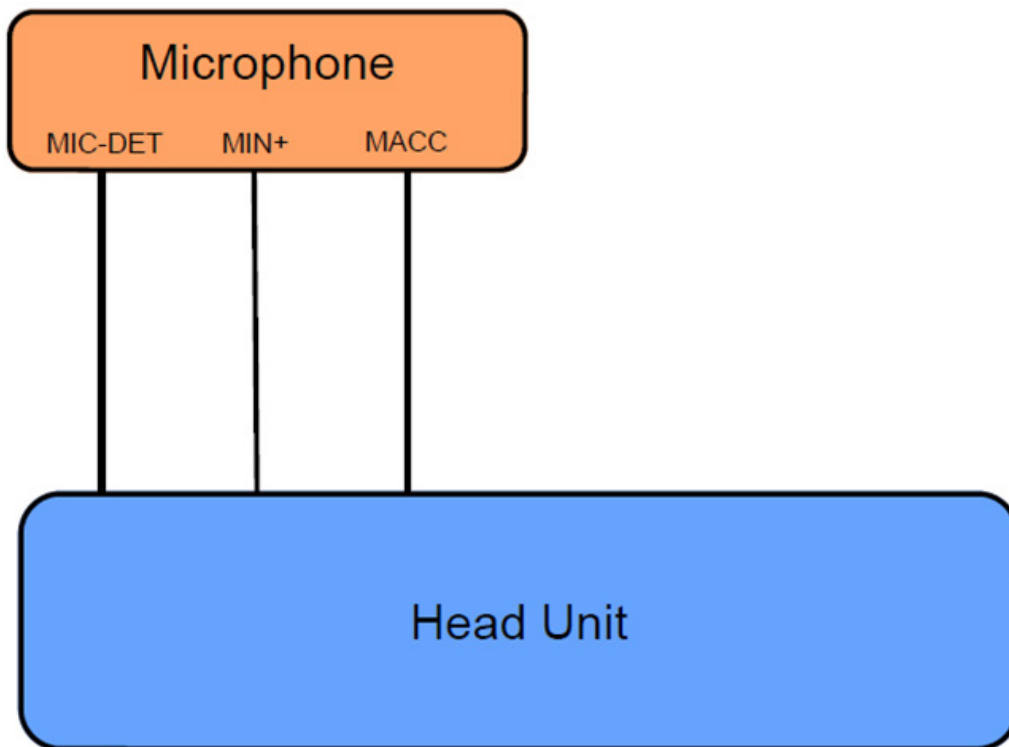
- Microphone is not properly connected to the head unit
- Microphone detection wiring (MIC DET) is open
- Microphone unit is defective

- Confirm the microphone wiring is securely connected to the head unit.
- Confirm there is not an open circuit or short in the Microphone detection (MIC DET) wiring.
- After the wiring has been confirmed to be OK, replace the microphone if necessary.

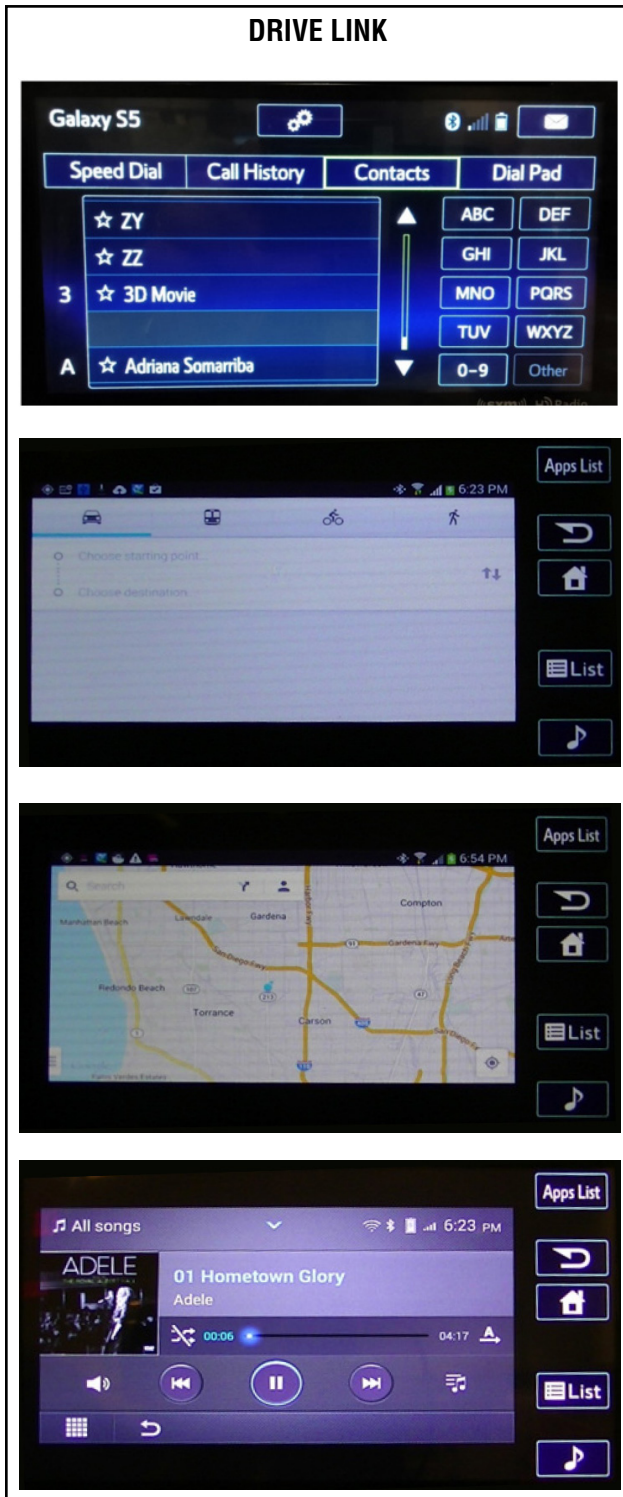
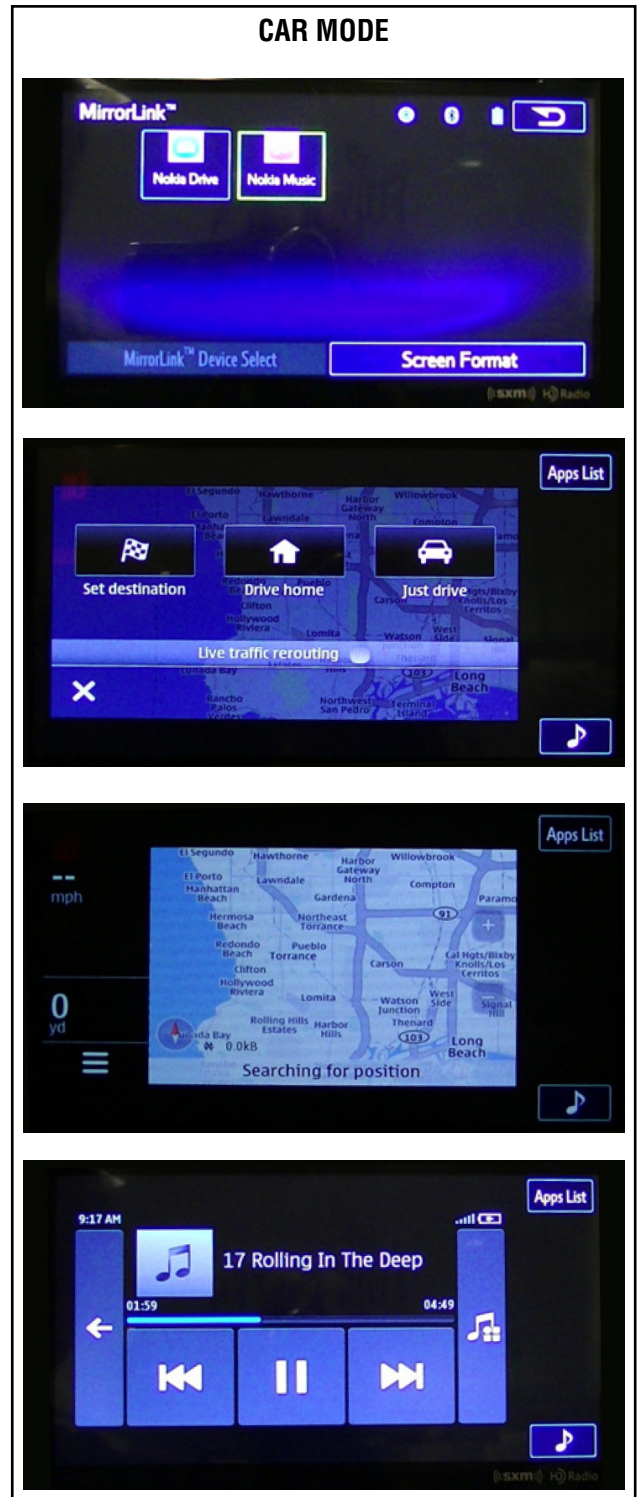
CONDITION #6: MirrorLink screen does not look the same when using “Drive Link” and “Car” mode.

Drive Link and Car mode display screen information on the head unit differently.

Explain to the customer, Drive Link and Car modes will display information differently when accessing the MirrorLink feature of the head unit. Examples of each are shown in the screen shot photos below.

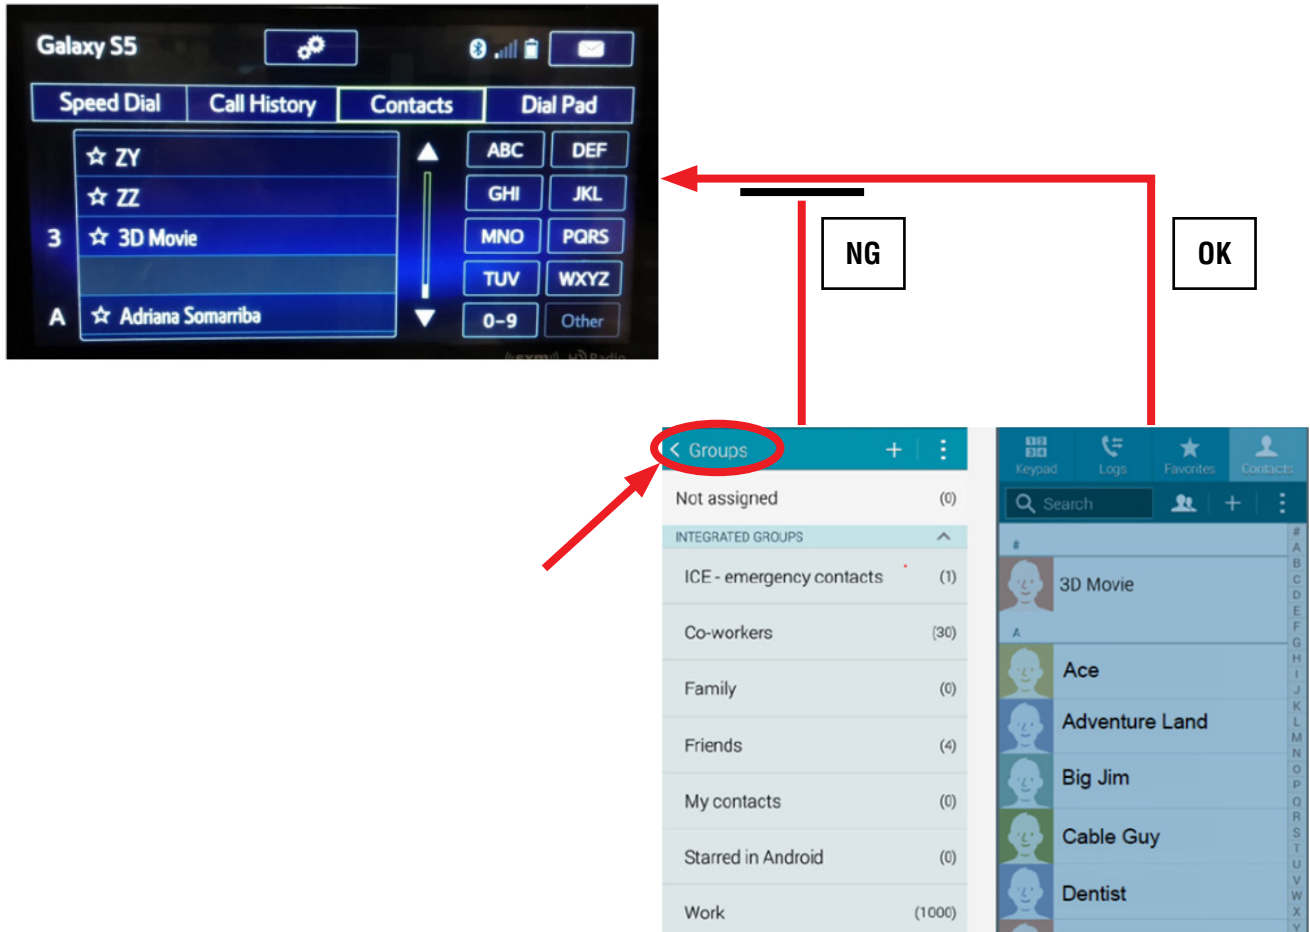
CONDITION #7: Individual contacts will transfer to the head unit from the smartphone, but group folders will not.

Although the head unit can retrieve individual contacts, it does not have the capability to retrieve group folders from the smartphone.

Explain to the customer, the head unit does not support the transfer of group folders from their smartphone.
