Bulletin No.: 14176
Date: August 2014

Recall Bulletin

SUBJECT: Improperly Crimped Accelerator Pedal Position Electrical Terminals

MODELS: 2014 Cadillac ATS

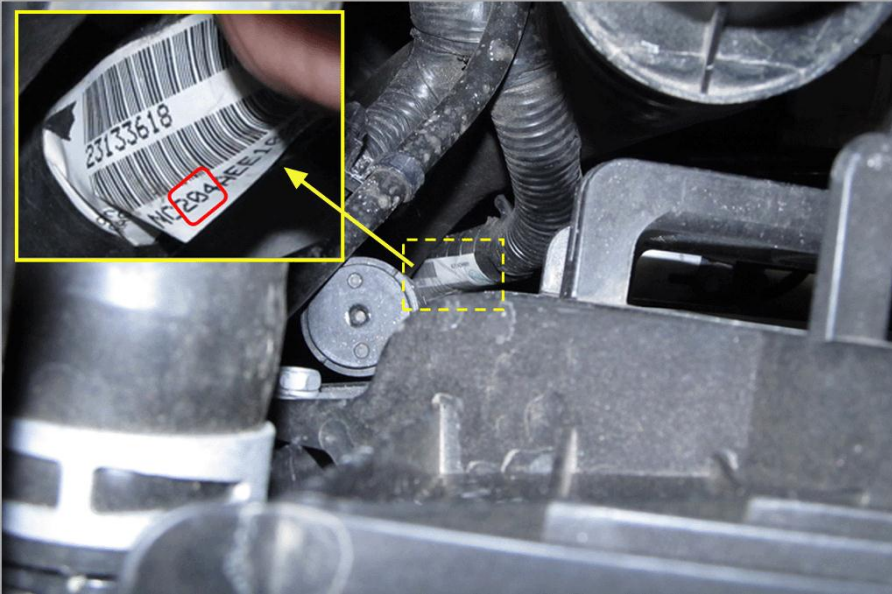
3942442

Tag and Date Code as Viewed from Top on a Four Cylinder Vehicle

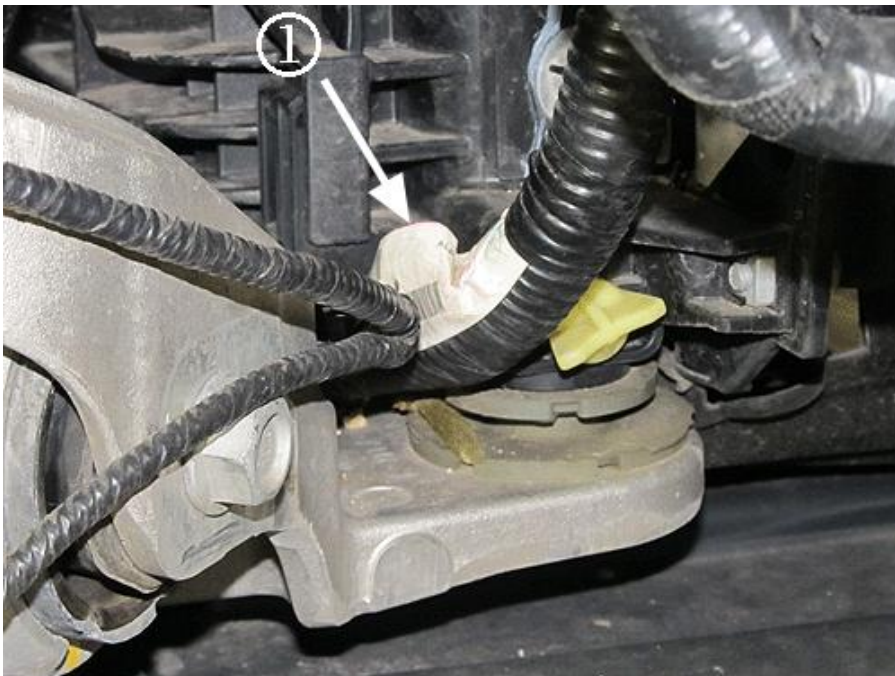
3942440

Tag (1) as Viewed from Bottom on a Six Cylinder Vehicle

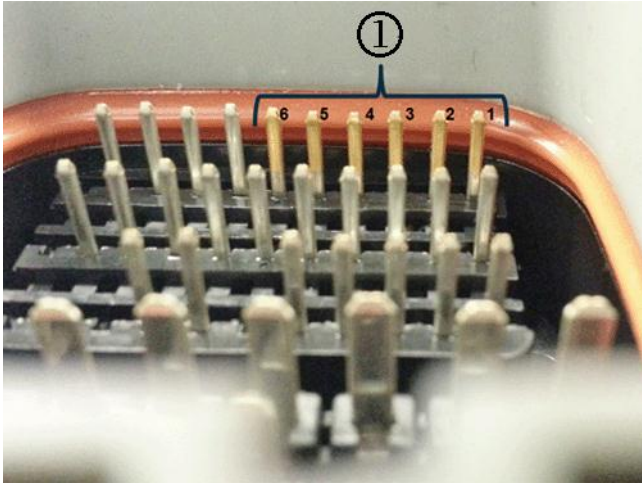
3942449

Caution: The Accelerator Pedal Position (APP) sensor circuits are cavities 1 through 6 within the X150 connector. All six terminals for APP must be gold plated.

7. Disconnect the connector and inspect the engine-side (male) terminals, 1 through 6 (1). As shown in the graphic above, the six terminals are gold and the surrounding terminals are tin.
 - If the Julian date code is **outside** the 182 – 187 range AND all six terminals are gold plated, no further action is required. Proceed to *Reassembly Procedure* below.

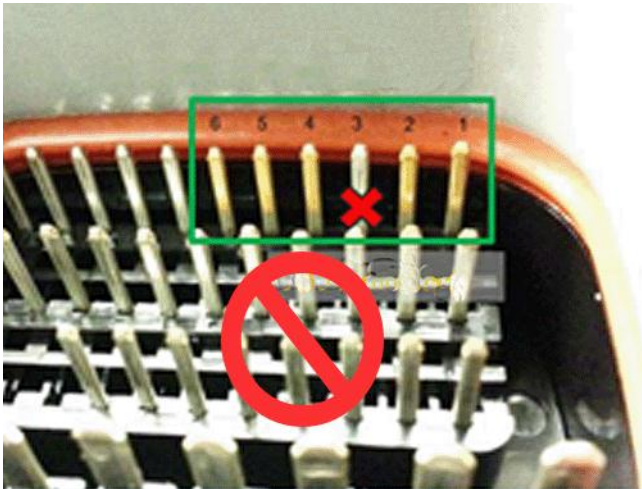
3942450

- If the Julian date code is **outside** the 182 – 187 range AND any tin plated terminals are found (like example shown in third terminal above), proceed to *Terminated Lead Replacement Procedure* below.

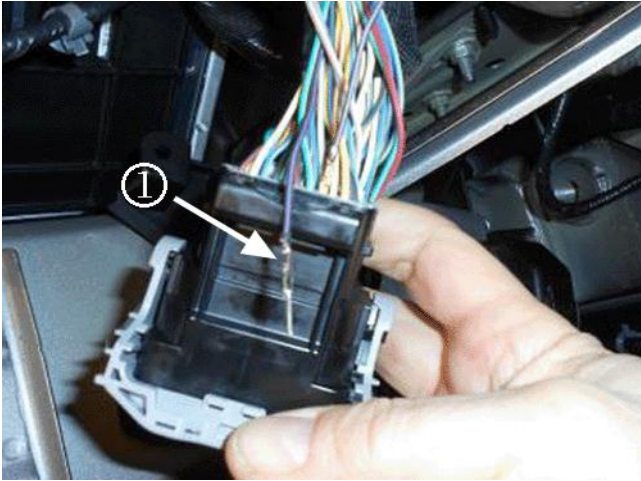
3942454

3. Using a pick (J-38125-11A), or equivalent tool, carefully back out the incorrect tin plated terminal (1) from the connector housing.

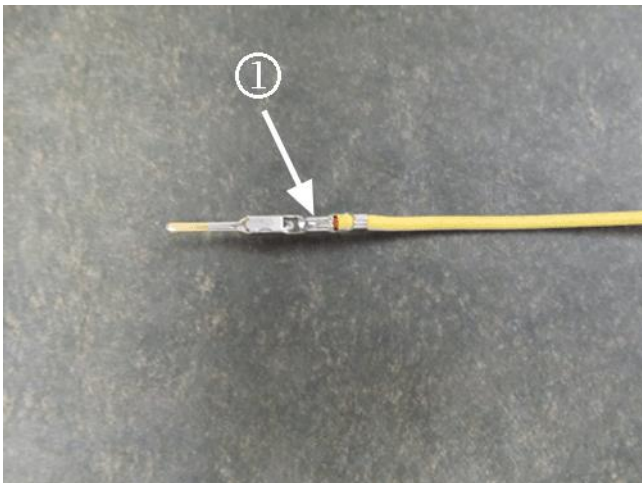
3943674

Caution: Use a small amount of solder (1) and verify the solder flows into the crimped bare wire end.

4. Verify the quality of each terminal solder.
5. Reinstall the gold plated terminal into the connector cavity. Ensure that the terminal is fully inserted into the connector, until it clicks using the push-click-pull method.
6. Repeat steps 2 – 4 as necessary for all additional **original** gold plated terminals within the 1 – 6 cavities.
7. Once all tin plated terminals are replaced AND all remaining original gold terminals are soldered, proceed to *Reassembly Procedure* below.
