Service Bulletin

SUBJECT: Special Coverage Adjustment – Excessive Engine Oil Consumption

**MODELS: 2010 Chevrolet Equinox
2010 GMC Terrain
Equipped with 2.4L Engine (LAF)**

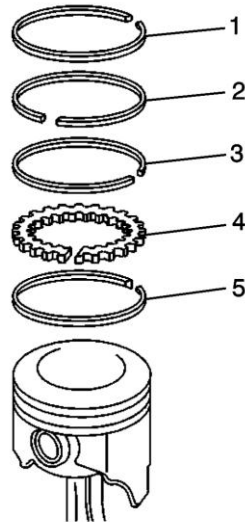
2146346

Some 2010 model year Chevrolet Equinox and GMC Terrain vehicles, equipped with a 2.4L engine, may exhibit excessive engine oil consumption (less than 2,000 miles per quart of engine oil), due to piston ring wear. If this condition is present, the oil can light may illuminate on the instrument panel or one of the following messages may appear in the Driver Information Center: “Engine Oil Low – Add Oil” or “Oil Pressure Low – Stop Engine”.

- Engine Replacement
 - Technical Service Bulletin 13-06-01-003F
 - Piston and Connecting Rod Disassemble
 - Piston and Connecting Rod Assemble
 - Piston, Connecting Rod, and Bearing Installation (LAF, LAT, LE5, LE9, LEA, or LUK)
1. Remove the engine from the vehicle.
 2. Remove the pistons from the engine.
 3. Remove the pistons from the connecting rods.
 4. Discard the pistons and piston rings.
 5. Install the new piston rings onto the new pistons.
 6. Install the new pistons onto the connecting rods.
 7. Assemble the engine.
 8. Install the engine into the vehicle.
