# Program Bulletin

## CUSTOMER SATISFACTION PROGRAM

**SUBJECT:** Left Rocker Panel Split below B-Pillar

**MODELS:** 2014 GMC Acadia

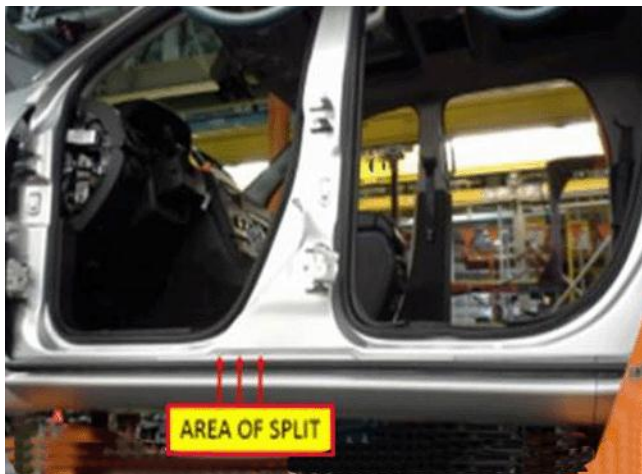
3961885

Use the following steps to inspect and repair the left rocker panel for a split in the metal. This condition is at the base of the B pillar just above the rocker panel molding.

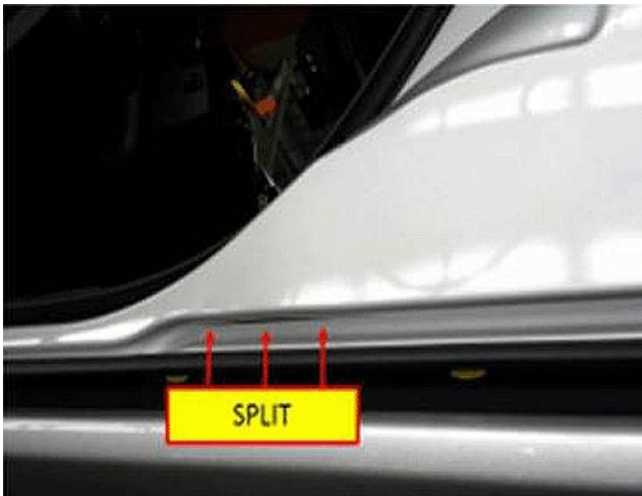
3961891

2. Open the driver side front door and inspect the area shown for any evidence of a small split in the metal. This may be indicated by small rust stains or peeling paint.
3. If a thorough inspection reveals no indication of a split, no further action is required. If there is evidence of a split condition, proceed to the repair steps listed below.

5. Locate the two ends of the split.
6. Drill a 3mm (1/8in.) hole at each end of the split.
7. Weld the split closed using MIG stitch welding.
8. To create a solid weld with minimum heat distortion, make 25 mm (1 in) stitch welds along the split with 25 mm (1 in) gaps between them. Then go back and complete the stitch weld.
