Program Bulletin

CUSTOMER SATISFACTION PROGRAM

SUBJECT: **Seat Mounted Side Impact Airbag Connector**

MODELS: **2014 Chevrolet Silverado 1500**
 2014 GMC Sierra 1500

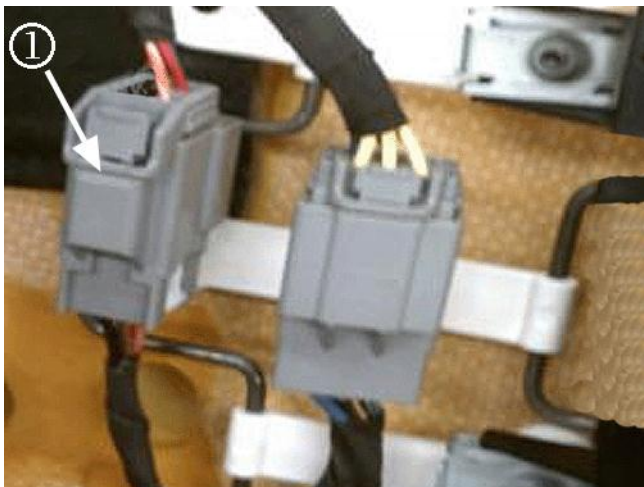
3957349

1. Starting on the passenger seat, locate the inboard grey SIAB harness connector (1) on the underside of the seat cushion.

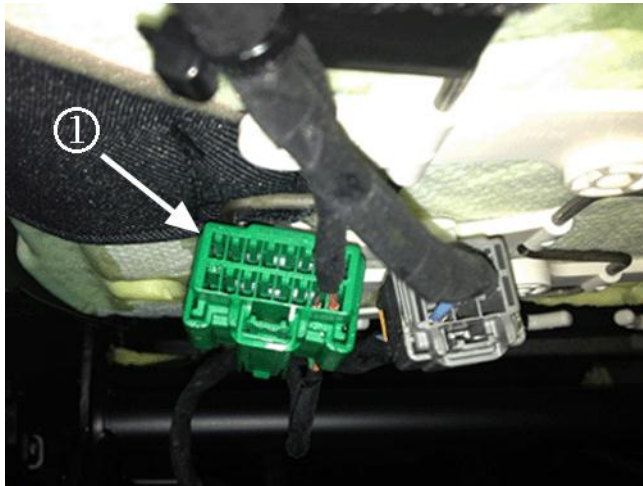
3957382

14. Moving to the driver seat, locate the outboard green SIAB harness connector (1) on the underside of the seat cushion.
