SERVICE BULLETIN

APPLICABILITY: 2015MY Legacy and Outback Models **NUMBER:** 12-176-14
SUBJECT: Service Procedure to Address a Wind Rushing Sound **DATE:** 12/05/14
 from the Front Door Sash Area

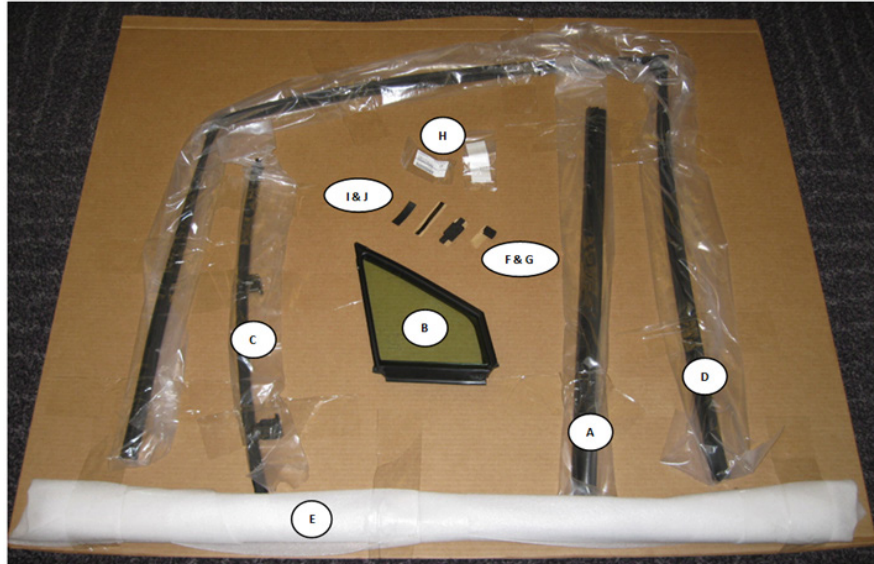
The parts kit will consist of the following components: (p.n. 61099AL00A (Right Front Kit is shown)

ID	DESCRIPTION	QUANTITY
A	Weatherstrip Inner	1
B	Glass Assy.	1
C	Sash	1
D	Glass Run Channel	1

ID	DESCRIPTION	QUANTITY
E	Weatherstrip Outer	1
F	EPT Foam Piece #1	1
G	EPT Foam Piece #2	1
H	Rivets	3
I	Non-Woven Tape	1
J	Butyl Tape	1
