TECHNICAL BULLETIN
JTBO0240NAS2
25 MAR 2014

Rattle Noise from Roof Opening Panel / Headliner Area

XF (X250)
Model Year: 2009-2013
VIN: R00019-U08603

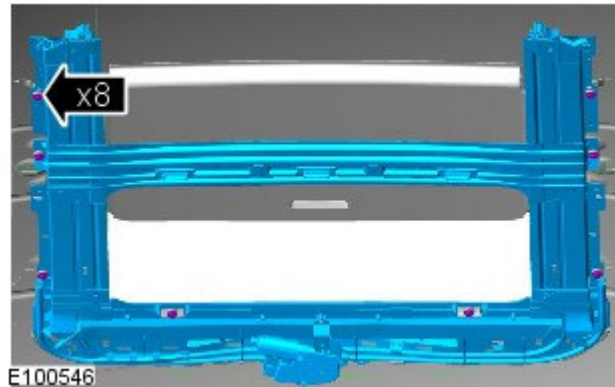
Cause: This may be caused by torque relaxation of the roof opening panel fixing screws.

Apply suitable thread locking adhesive to the eight (8) bolts:

- Remove one bolt.
- Apply suitable thread locking adhesive to the thread on the bolt.
- Install the bolt; torque to 9Nm.
- Repeat the procedure to the other 7 bolts.
