TECHNICAL BULLETIN  
JTB00160NAS3  
28 APR 2014

Front Door Exterior Handle Sticking in the Open Position

**XF (X250)**

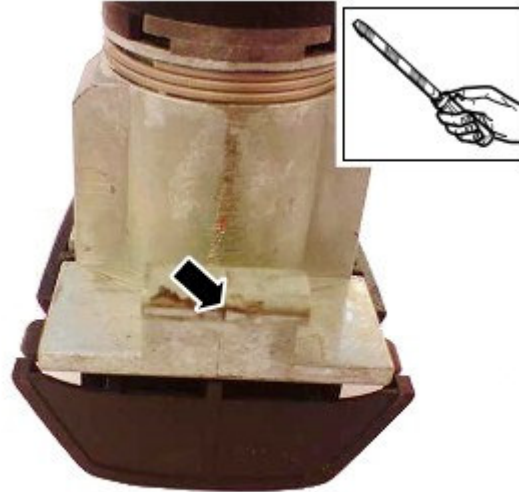
E119185

**CAUTION: Remove only the burr and split line; DO NOT remove any material from the radius.**

**CAUTION: Do not remove any material from the right-hand exterior door handle bezel.**

**Left-hand only:** place the door lock cylinder with the key slot face down and file the moulding split line to remove the burr from the radius.

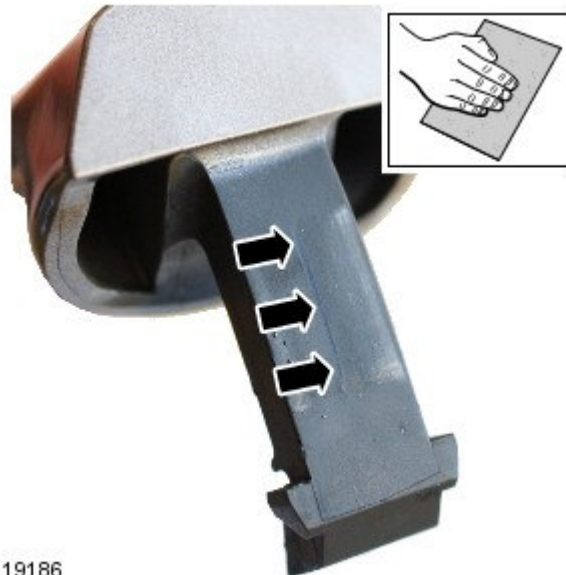
E119186

**NOTE: Using a suitable degreaser, clean the handle before and after removing the moulding split line.**

**NOTE: Remove only the moulding split line; DO NOT remove any material from the door handle strap.**

**Left-hand and right-hand:** using suitable 800-grit abrasive cloth, remove the moulding split line from the center of the door handle strap.

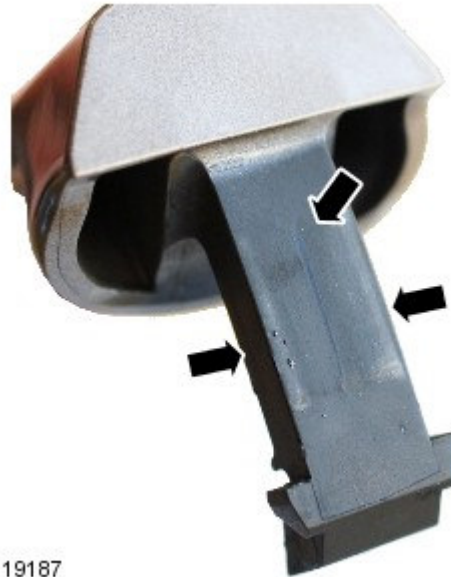
E119187

**NOTE: Do not use excessive lubricant.**

**Left-hand and right-hand:** lubricate the handle strap face surface and side surfaces using a KSP 105 from the oil and grease kit.

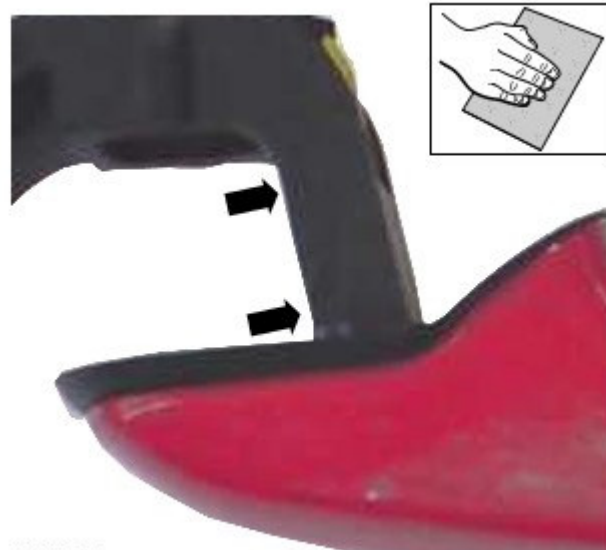
E119188

**NOTE: Using a suitable degreaser, clean the handle before and after removing the burr/flash.**

**NOTE: Do not use excessive lubricant.**

**Left-hand and right-hand:** using suitable 800-grit abrasive cloth, remove the burr/flash from both rear edges of the strap until smooth (arrowed in graphic).

- Lubricate the rear face and sides using KSP 105 from the oil and grease kit.

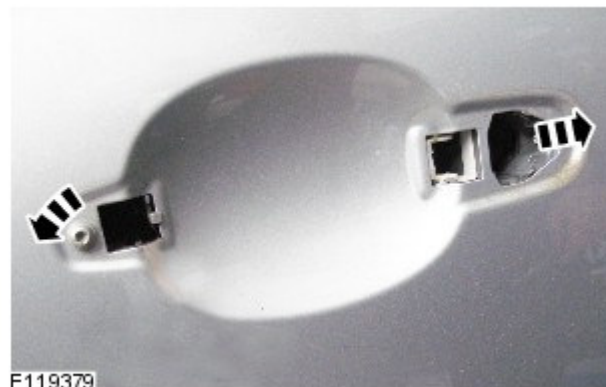
E119379

**NOTE: Do not remove the retaining screw completely.**

Loosen the retaining screw and slide the handle securing plate rearwards, ensuring the location lugs are tight against the door panel aperture.

- Tighten the retaining screw.
