TECHNICAL BULLETIN
JTB00176NAS2
28 APR 2014

Headlamp Internal Condensation

XF (X250)

XK Range (X150)

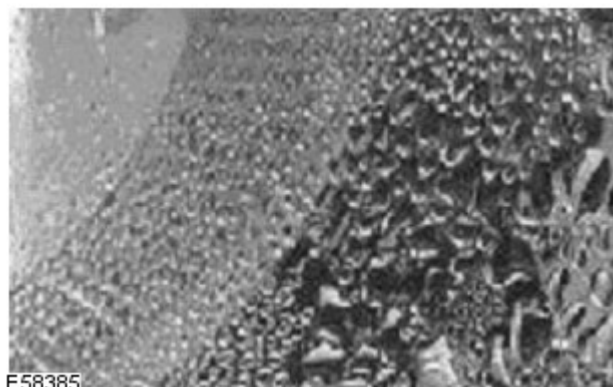
E58385

5. Large apparent visible droplets of water on the interior side of the headlamp lens.
