TECHNICAL BULLETIN
JTB00345NAS3
15 APR 2014

Door Window Regulator 'Squeak' Noise During Operation

XF (X250)

XJ Range (X351)

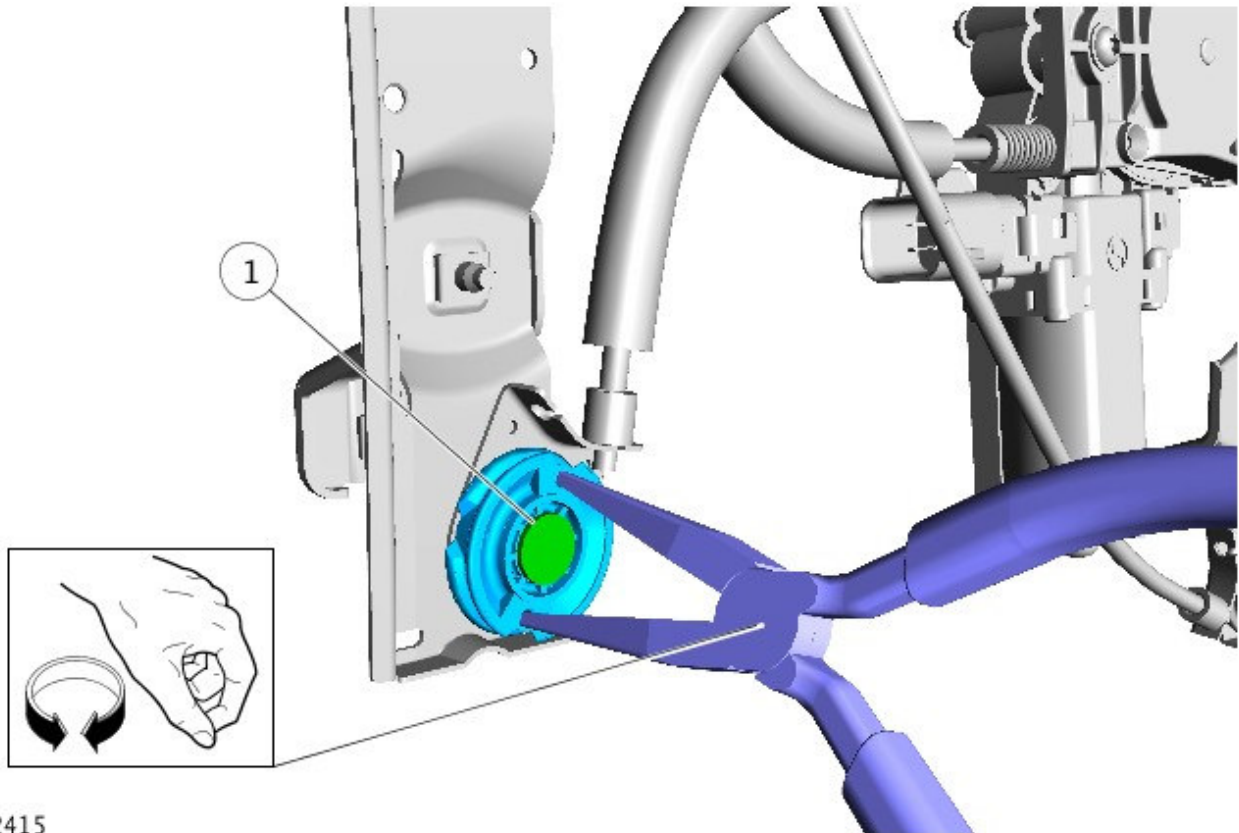
E162415

Cause: This may be caused by inadequately lubricated door window regulator cable pulleys.

Mount the regulator vertically. Continue applying lubricant in a fine mist until good penetration is achieved between the roller and its pivot.

- Using a suitable tool, rotate the cable roller back and forth while lubricating point '1' with LIP anti-friction spray (AC612/21) from the Squeaks & Rattles kit.
- Repeat the process for each roller on the door window regulator.
