TECHNICAL BULLETIN
K192NAS1
07 APR 2014

Service Action: Folding Top Enhancement Program

F-TYPE (X152)

Model Year: 2014
VIN: K00317-K05500

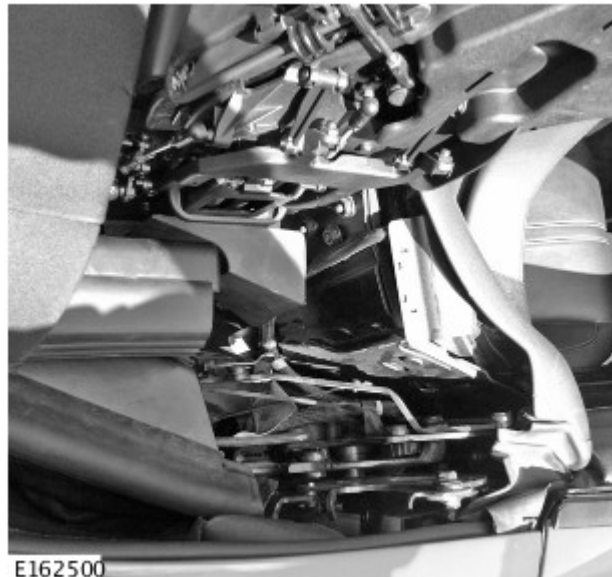
E162500

6. With the folding top in the open position, operate the folding top switch until the secondary folding top flaps are in the raised position.
 - Check for wiring harness damage and harness position under both of the folding top flaps.

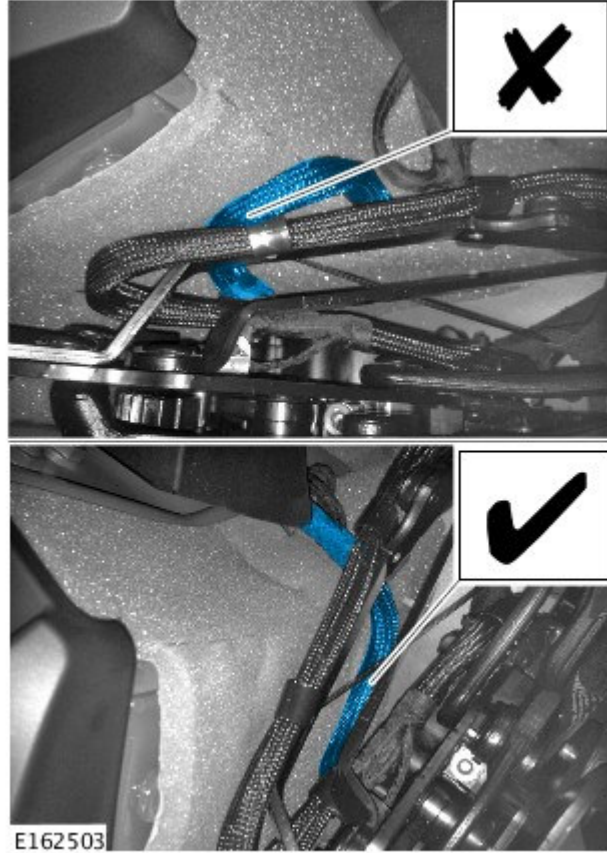
**NOTE: Left-hand harness shown.**

Inspect the left-hand harness; make sure left-hand harness is looped below the link and pulled down rather than trapped between the link and the foam.

- If the harness is routed correctly, continue to Tape Header Trim.
 - If the harness is not routed correctly, disconnect the harness to manipulate it to the correct position..
- Once the harness is positioned correctly, continue to the next step.

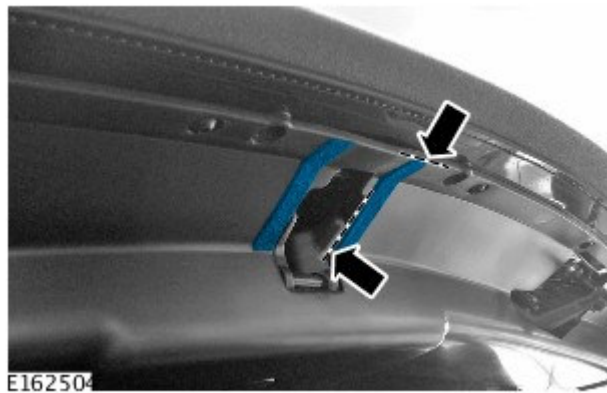
1. When in the stowed (open) position, the folding top may contact the flaps in the corner.
2. The routing of the folding top harness may cause fouling on the folding top mechanism to wear through the braiding.
3. As a result of normal opening / closing of the folding top, the lower header trim contacts the carpet bezel. This contact, over time, may result in white marks on the header trim.

- 10.** Install the tape to align with front edge of header trim and edge of hole feature.
