# TECHNICAL BULLETIN

## JTB00306NAS3

### Suspension 'Knock' / 'Creak' Noise From Rear of Vehicle

#### **F-TYPE (X152)**

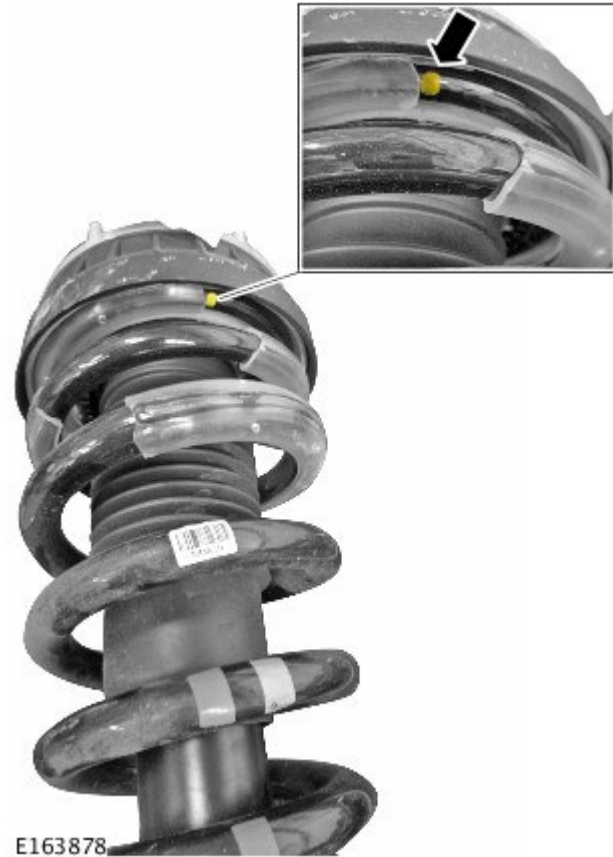
1. Remove the rear right shock absorber / coil spring assembly (see TOPIx Workshop Manual, section 204-02).
2. Make a note of the paint mark on the spring.

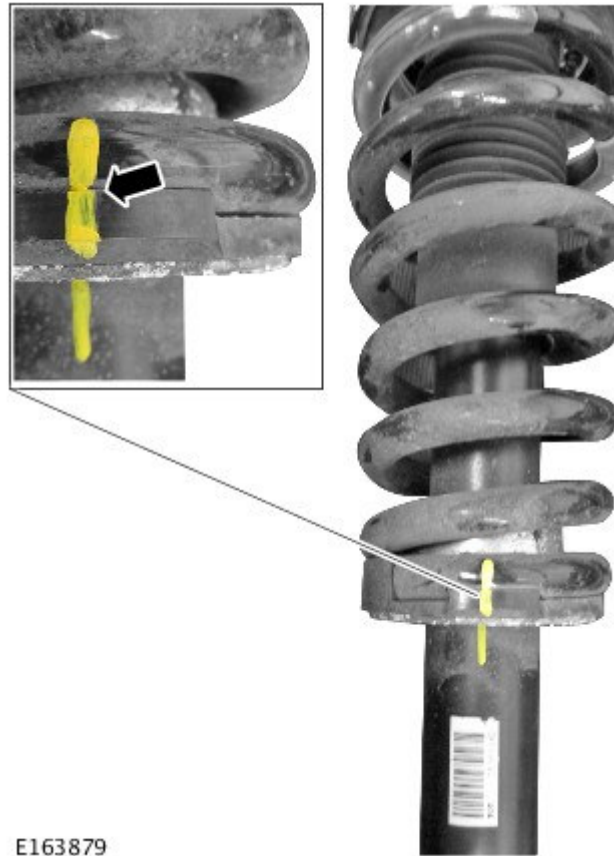
E163879

3. Using a suitable marker, make an alignment mark through the spring, packer and shock absorber.

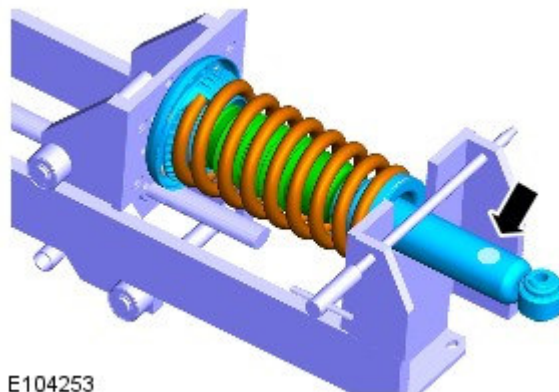
E104253

**NOTE:** Make sure that the spring and shock absorber assembly is installed to the spring compressor with the alignment mark facing upwards.

Using a suitable spring compressor, remove the spring assembly top mount.

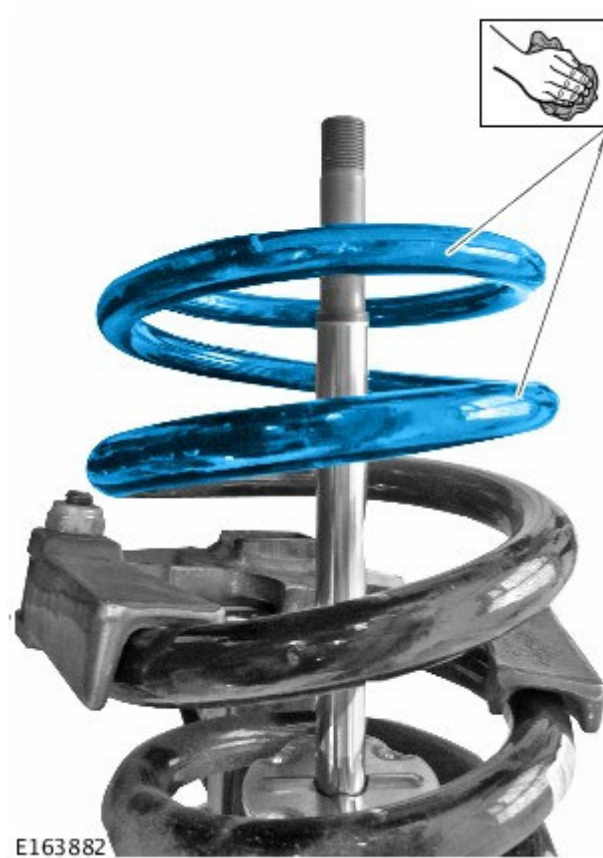
**NOTE:** If previously fitted, remove all spring isolator sleeves.

Using a suitable cloth, clean the spring in the section where the new sleeve is to be installed.

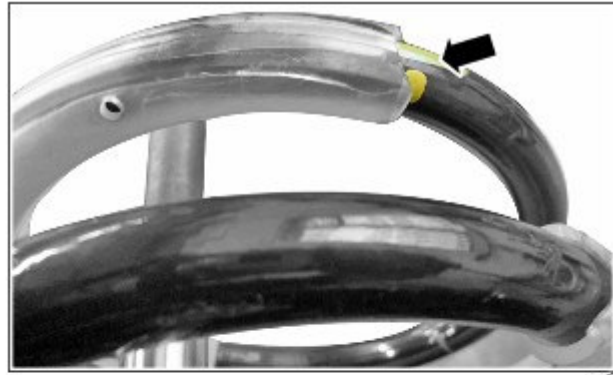
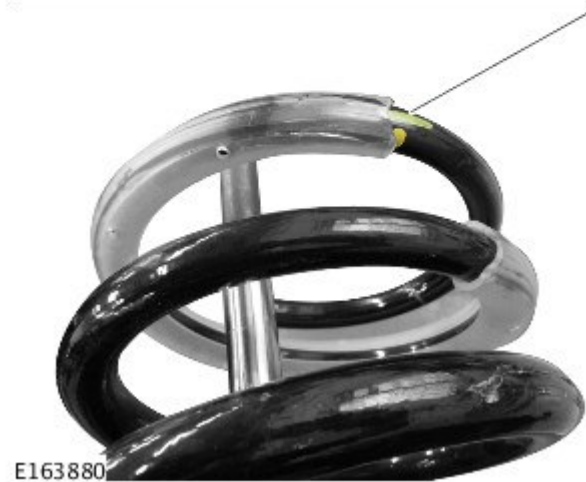
**NOTE: Note the paint mark.**

Install the new sleeve.

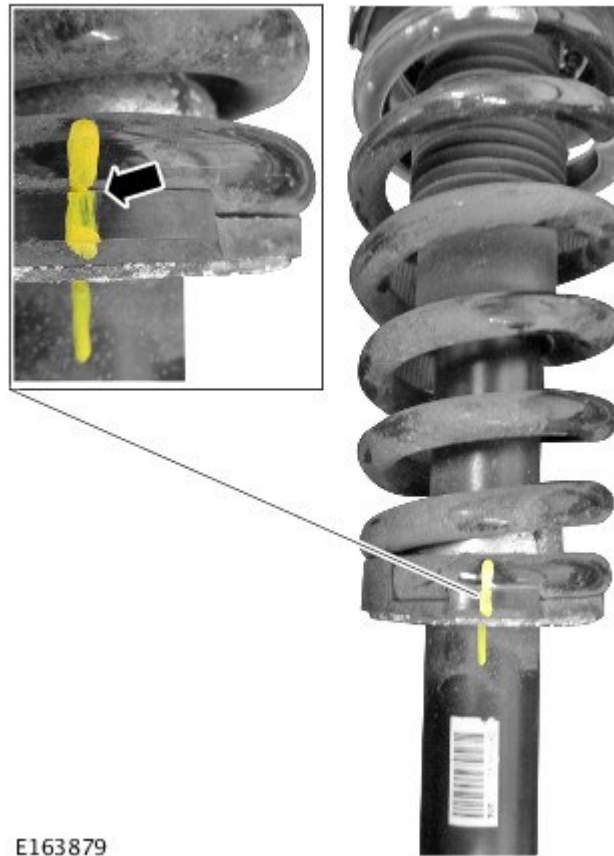
E163879

**NOTE: During assembly, make sure that the alignment marks line up.**

Install the spring assembly top mount.

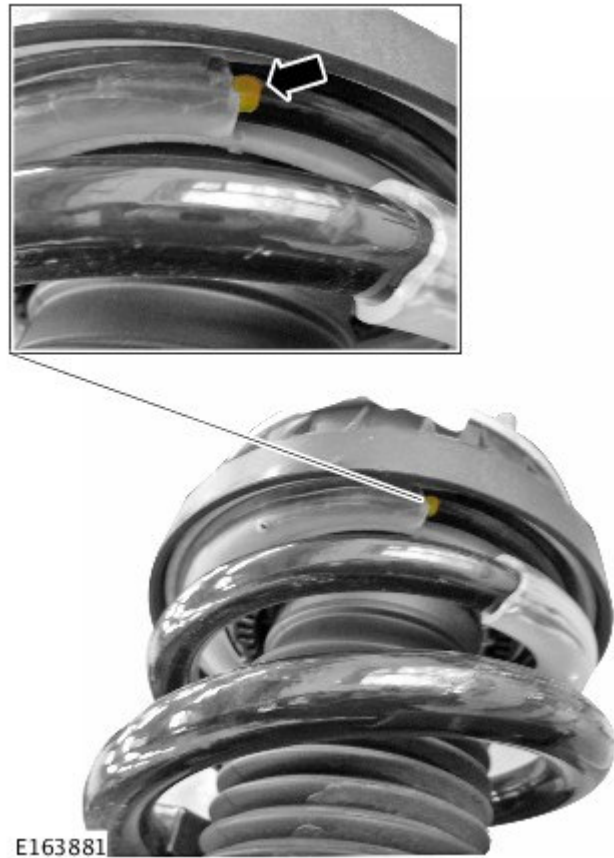
**NOTE: Make sure the spring assembly is located in the top mount correctly.**

Tighten to:

- Without Dynamic Suspension: 50Nm.
- With Dynamic Suspension: 27Nm.
