TECHNICAL BULLETIN
K245 UPS5314-4bNAS1
09 OCT 2014

Update Prior to Sale: Driveshaft Fixings

XJ Range (X351)

Model Year: 2014
VIN: V71369-V71498

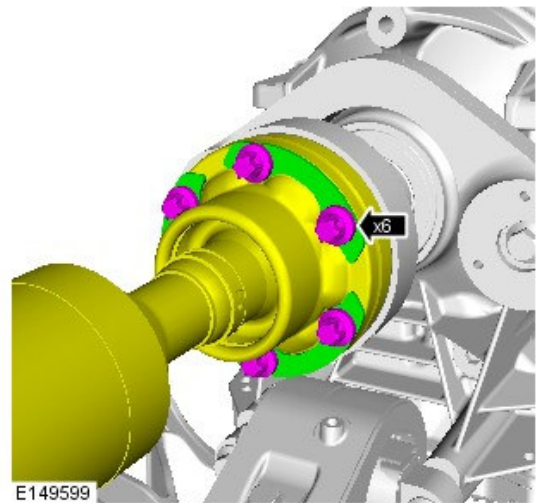
8.

Situation: A potential issue has been identified on a number of 2014 model year XJ (X351) vehicles, fitted with the 3.0L V6 supercharged engine only, where the driveshaft fixings may not have been tightened to the correct torque value.

**NOTE: Retain the locators for use with the new retaining bolts.**

**NOTE: Tighten the fixings in sequence directly across/180 degrees (criss-cross).**

Install the six (6) new retaining bolts.

- Torque: 75 Nm
