**Document ID:** IK1201118  
**Revision:** 2  
**Created:** 5/1/2014  
**Last Modified:** 12/10/2014  
**Author:** Ted Grzeskowiak

**Title: Big Bore Intake Air Temperature/CACOT Sensor Damaged**

**Applies To: Prostar 113 Equipped with 2010 Emissions MaxxFORCE 11/13L and N13 Engines**

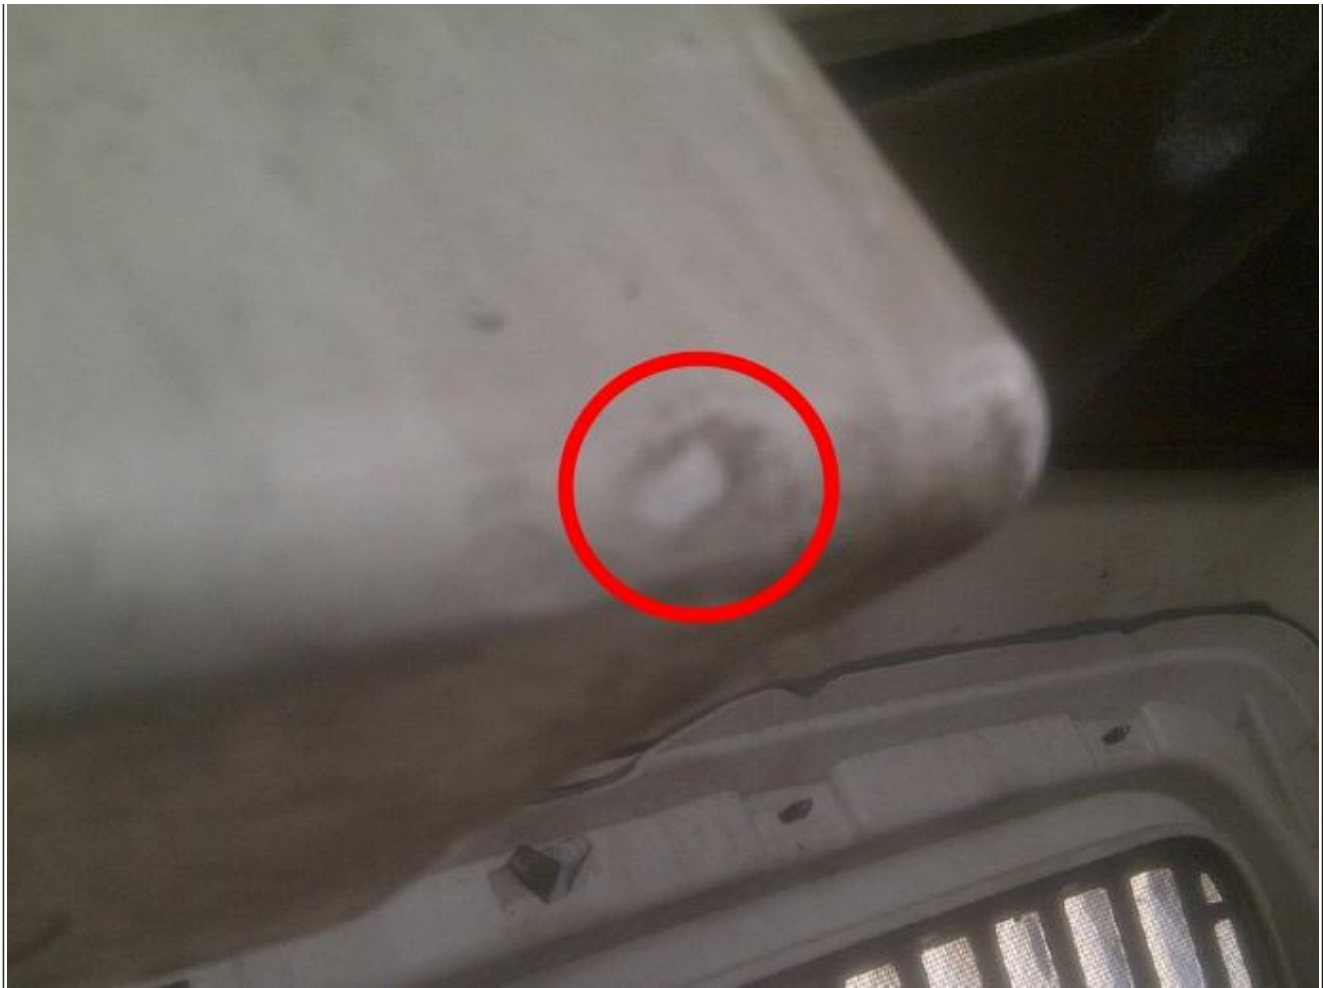
**Figure 2: Rub mark in the hood from CACOT sensor contact (air inlet cowl).**

Step	Action	Decision
2	<p><b>Verify hood to sensor contact.</b></p> <ul style="list-style-type: none"> <li>• Inspect the inside of the hood for markings from rubbing the CACOT sensor. See figure #2 below for an example of hood rubbing marks.</li> <li>• Are there witness marks on the hood?</li> </ul>	<p><b>1.</b> Yes. Proceed to hood modification procedure, below.</p>
		<p><b>2.</b> No. Diagnostic is finished.</p>

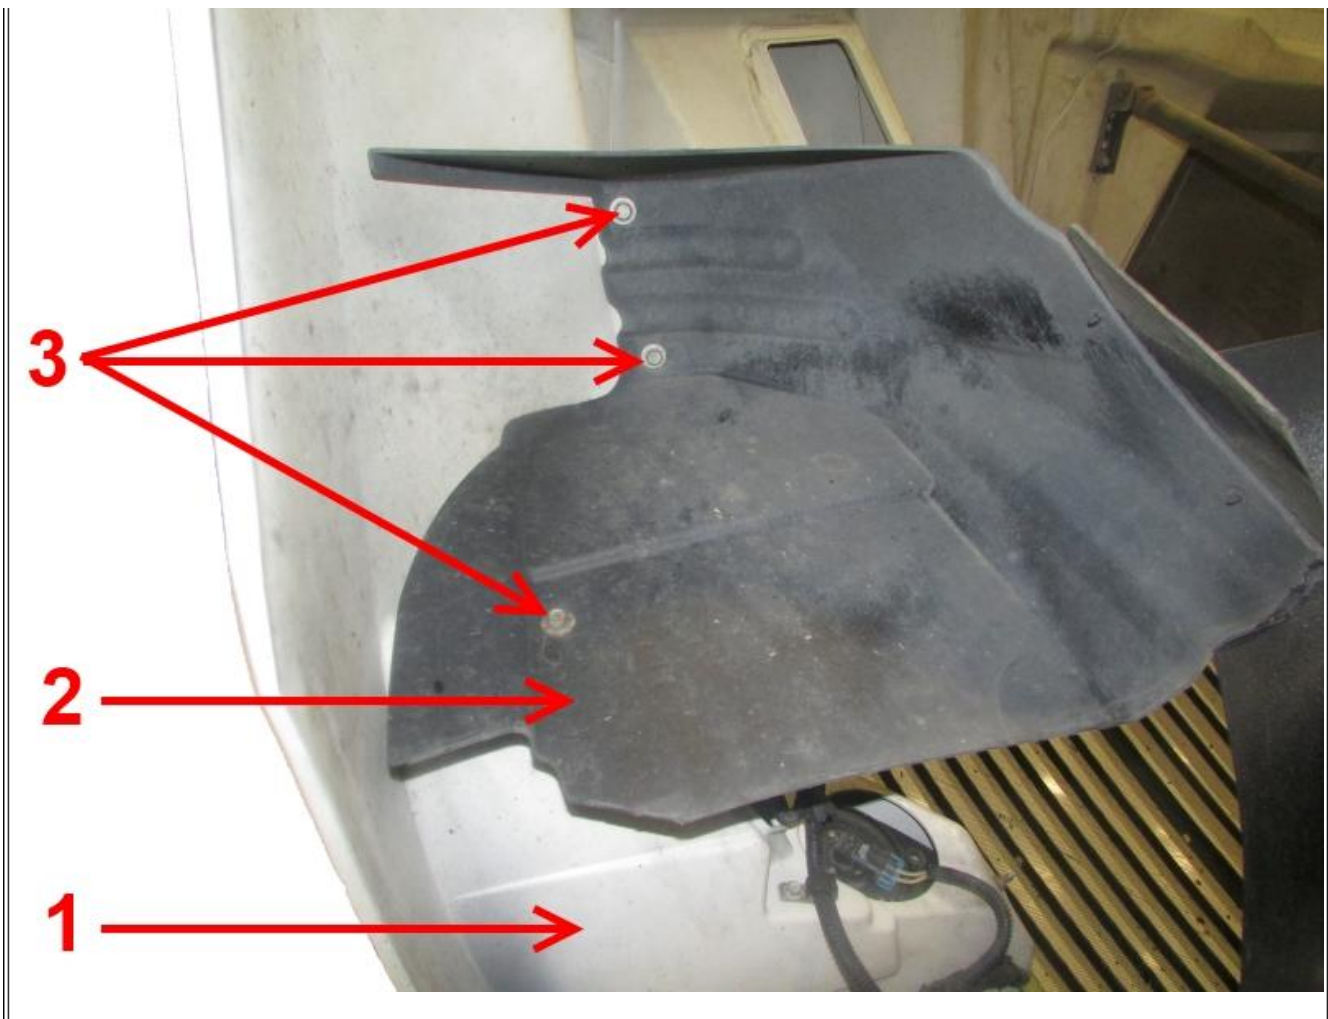
**Figure 3: Removal of inner fender.**

1. Remove the three bolts securing the driver side front inner fender to the hood.

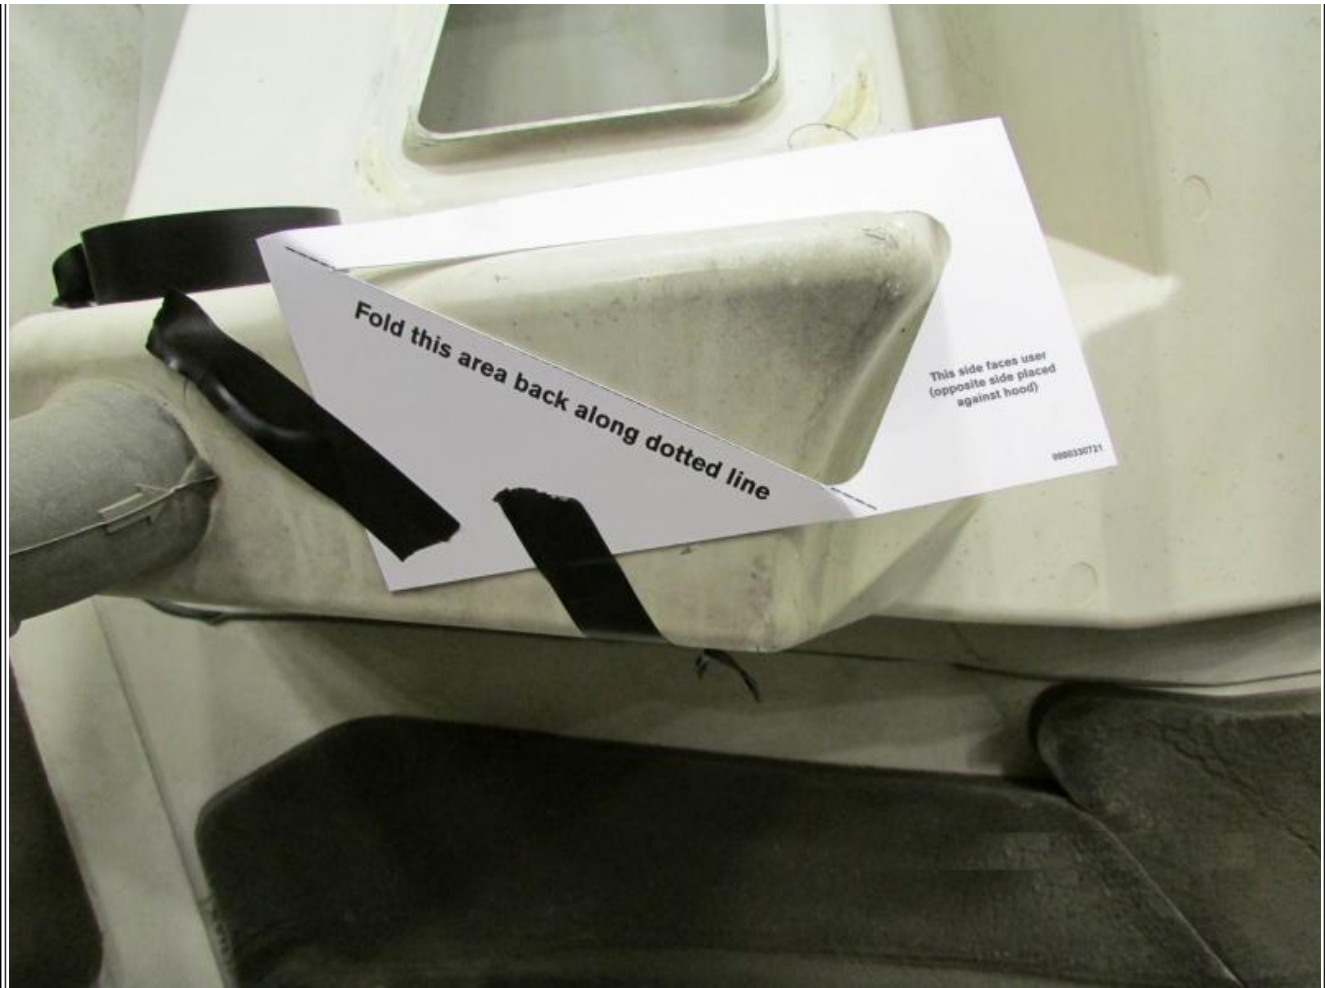
**Figure 4: Hood modification template**

2. Fold the template from the kit, as instructed, and secure it to the air inlet cowl on the hood, as shown in **Figure 4**.

**NOTE:** The template should sit approximately 1.5 inches over the "top right" corner of the air inlet cowl.

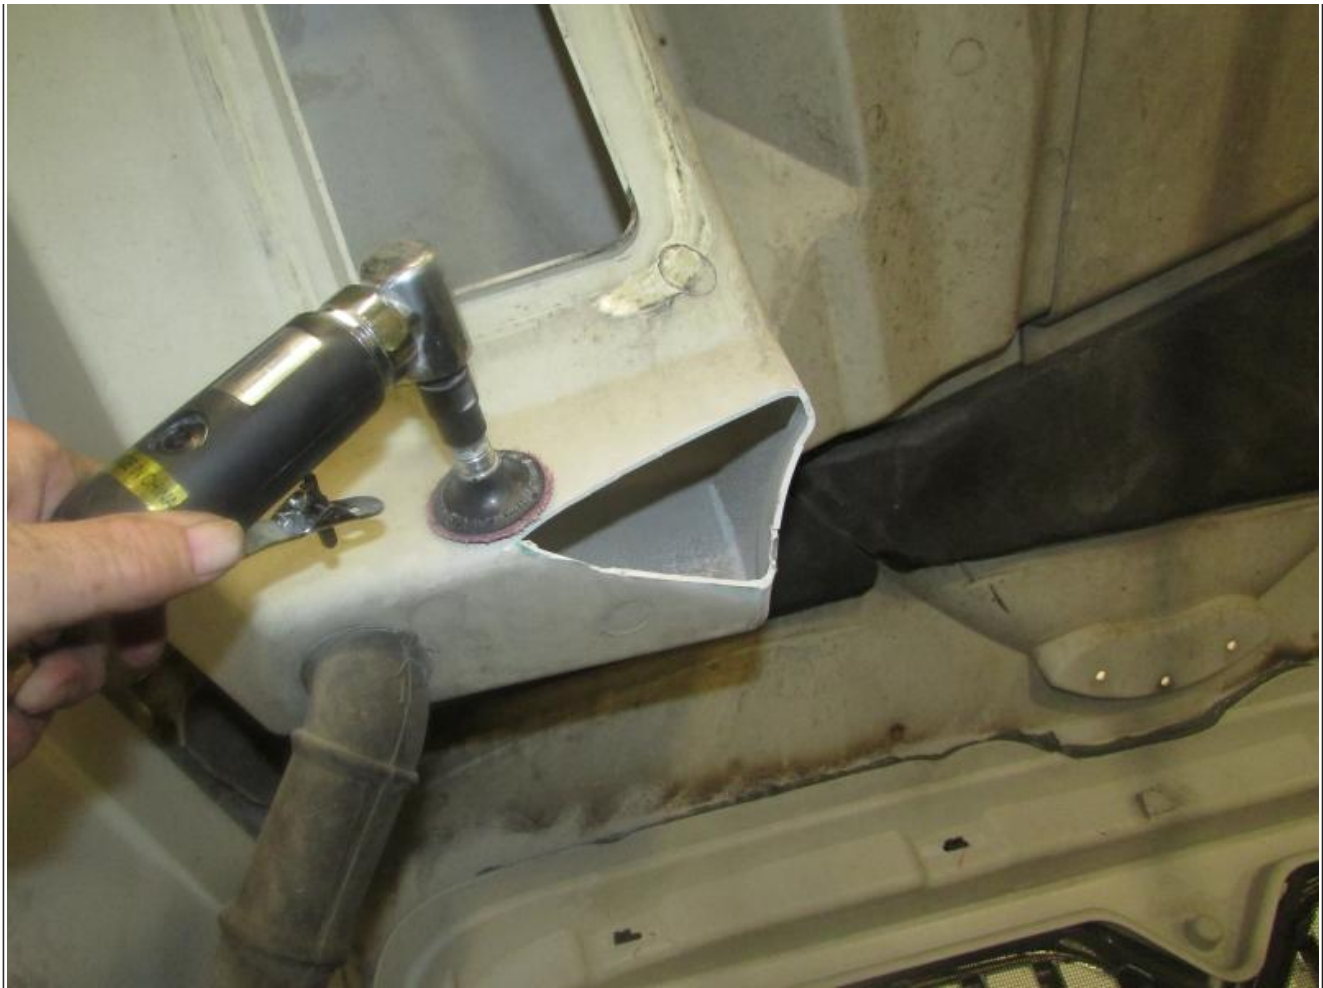
**Figure 8: Sanding/roughing of the patch area.**

5. Use the 3M pad (and tool) to rough up the area (roughly 7x7 inch square) around the removed section.

Sandpaper can be substituted, if necessary. Ensure no dirt/debris are still on the cowl and the surface finish is rough.
