TECHNICAL BULLETIN
K253 UPS6014-2bNAS1
13 NOV 2014

Update Prior to Sale: Brake Booster Solenoid Connector Spring Locking Mechanism Not Engaged

XJ Range (X351)

Model Year: 2014-2015
VIN: V73092-V75959

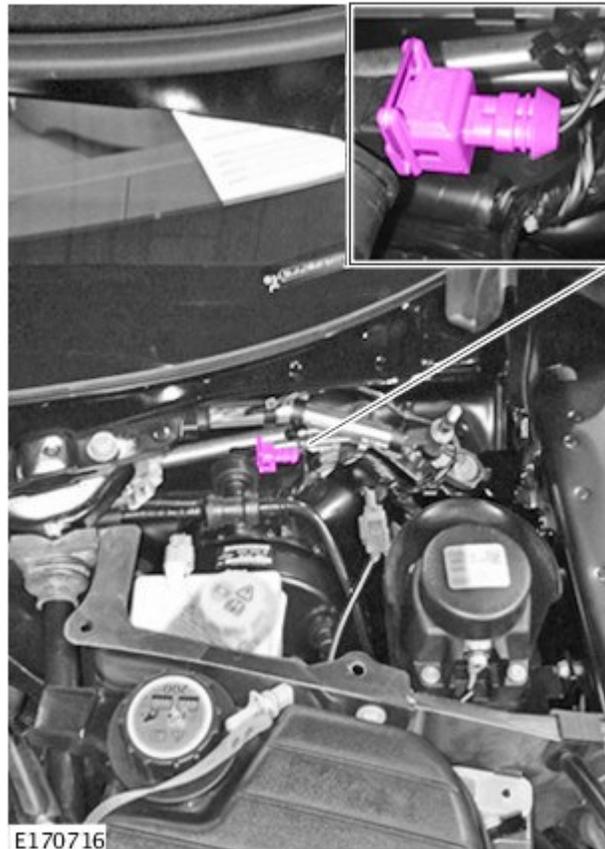
E170716

1. Remove the cowl vent screen (see TOPIx Workshop Manual, section 501.02).
2. Locate the brake booster solenoid electrical connector.

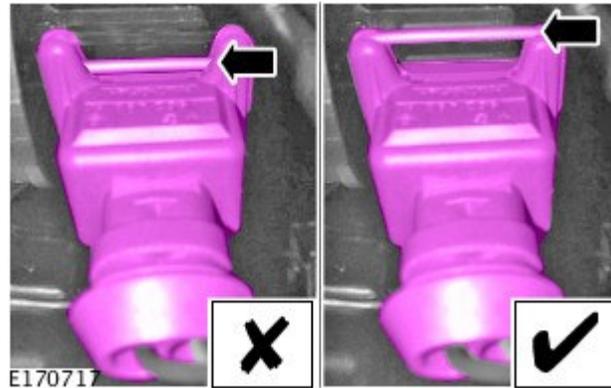
3. Verify brake booster solenoid electrical connector spring locking mechanism is in the 'latched' ('✓') position:

- 'X' = 'unlatched'

- '✓' = 'latched'; no further action required. Continue to the next step.

- If the brake booster solenoid electrical connector spring locking mechanism is NOT in the 'latched' position, re-connect the brake booster solenoid electrical connector fully so that the spring locking mechanism is fully latched ('✓').
