Reference	SSM72082
Models	F-TYPE / X152
	XF / X250
	XJ / X351
	XK / X150
Title	Twin Solenoid(TS) starter motor diagnosis
Category	Electrical
Last modified	24-Nov-2014 00:00:00
Symptom	203000 Basic Electrical
Attachments	ssm starter image.pdf
Content	Applicable Models and engine derivatives
	XK / X150 Engine AJ126 & AJ133 14 MY onwards
	F-TYPE / X152 Engine AJ126 & AJ133 14MY onwards
	XJ / X351 Engine TDV6, AJ126 & AJ133 13MY onwards
	XF / X250 & XE X760 Engine DW12 2.2 DIESEL, TDV6, I4 GTDi (2.0I), AJ126 & AJ133 12MY onwards
	Issue
	A significant number of TSS motors have been replaced under warranty, when returned to the supplier for analysis many are deemed as
	"No Fault Found".
	DTC's may be present, due to this carry out a DTC global read using the recommended diagnostic and follow the help text for each
	DTC's.
	It is possible during an ECO stop start that the vehicle does not re-start.
	Cause
	Incorrect diagnosis.

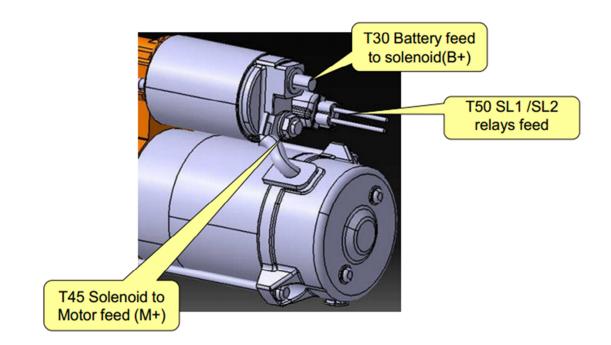
a) Check the pinion rotate relay (Relay Starter motor) and the wiring from the relay to the starter motor
	b) Check the connection at the T30 terminal (B+), <u>see attachment</u>
