TECHNICAL BULLETIN
K161NAS2
19 DEC 2014

SECTION: 211-02

Service Action: Steering Gear Fixing

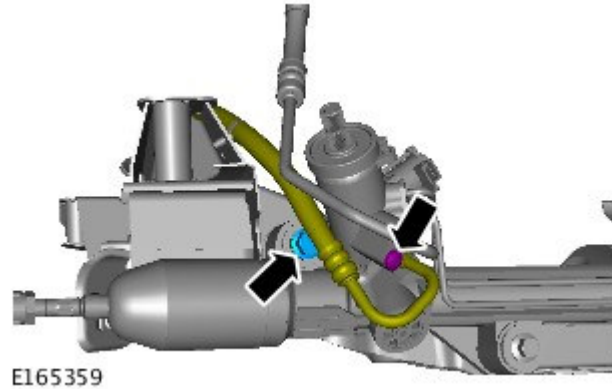
Situation: An issue has been identified on a number of XF (X250), XJ (X351), and XK (X150) vehicles where the residual torque on the steering gear pinion bolt could be below the lower specification and in some cases the customer may experience a knocking noise from the steering gear. The latter will only be the case if the early steering degradation is ignored by the customer.

Remove the steering gear upper bolt.

- If required, slacken the Torx bolt.
- If required, carefully reposition the power steering pipe.
- Remove the bolt.
