**Document ID:** IK0900087  
**Revision:** 4  
**Created:** 9/19/2013  
**Last Modified:** 11/3/2014  
**Author:** Steven Bell

**Title:** Low Power No MIL Diagnostics

**Applies To:** 2010 MaxxForce 11, 13L Engine N13 Engines

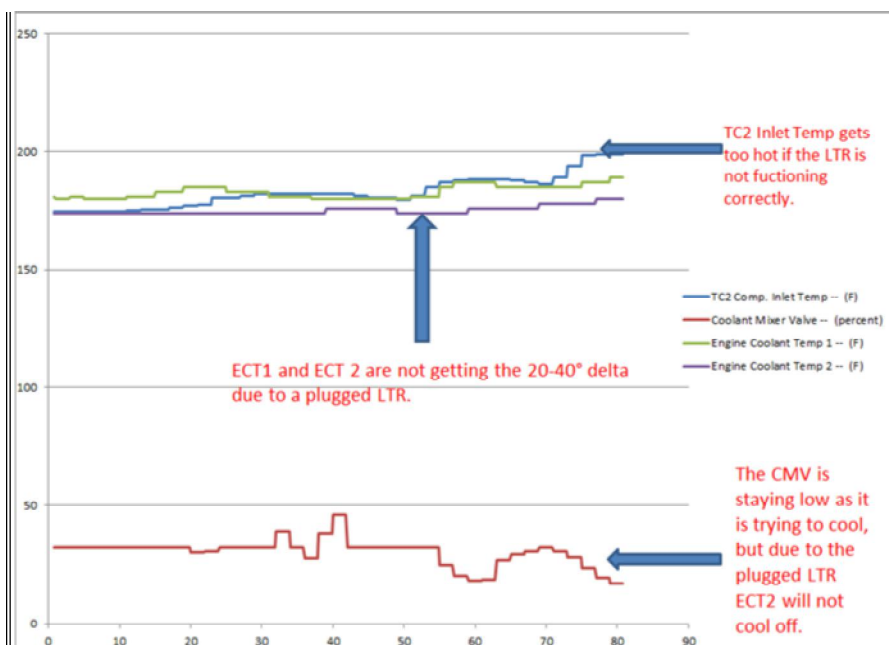
**Example Snapshot(s)****Graph 1: Plugged LTR**

Snapshot of a Plugged LTR

| Step | Action | Decision |
|---|---|---|
| | | No: Replace the LTR. Add Phosphate conditioner p/n 2611268C1 in cooling system when replacing the LTR. |

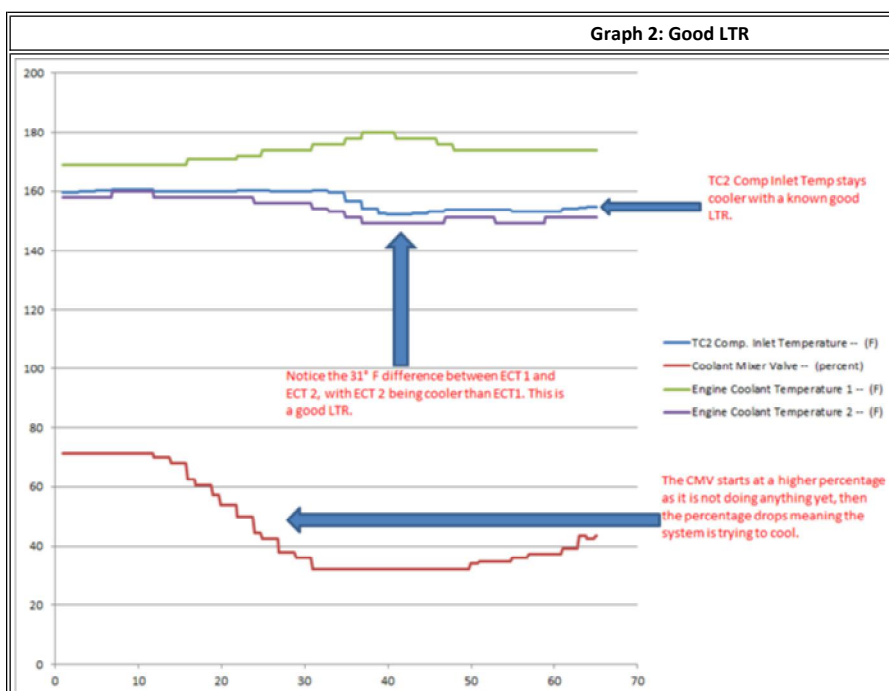
Snapshot of a Clean LTR

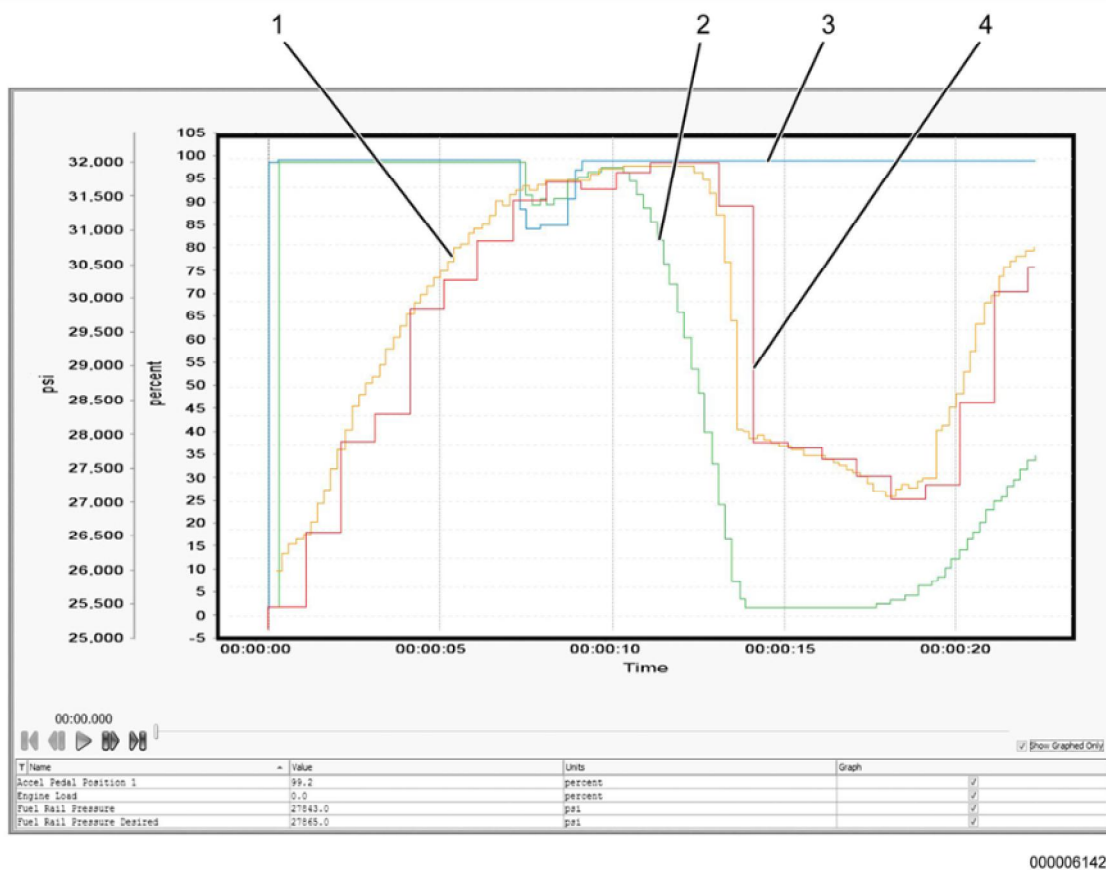
Graph 3: Lug Down test (Engine Speed, FRP, and FRPD)

This graph shows a fuel management system operating as designed. This test does not give pass or fail results. It only allows the user to validate Fuel Rail Pressure (FRP) and Fuel Rail Pressure Desired (FRPD) signal values under load. As engine rpm increases, Fuel Rail Pressure (FRP) should steadily increase. Low FRP will cause low Intake Manifold Pressure (IMP). Diagnose low FRP concerns before diagnosing low IMP concerns.

| Step | Action | Decision |
|---|---|---|
| | | No: Diagnose and repair low fuel rail pressure (See Performance Diagnostics section in Engine Diagnostic Manual). After repairs are complete, go to step 1 and recheck. |

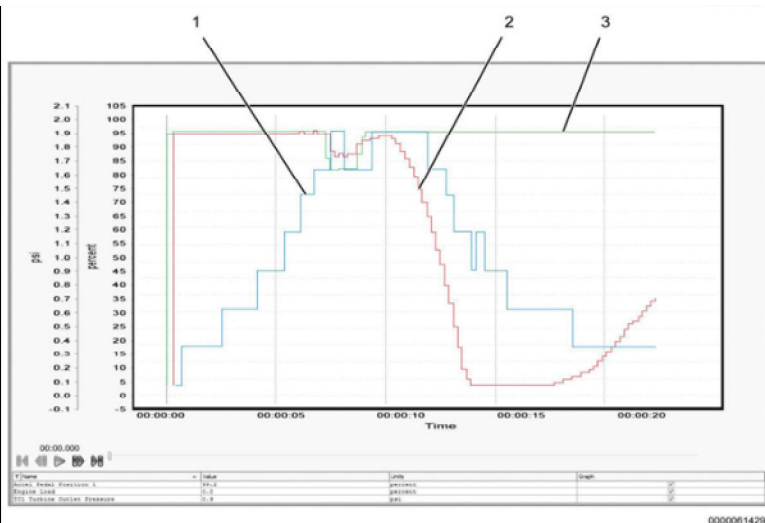
**Graph 4: Lug Down Test (Engine Speed and TC1TOP)**

This graph shows an exhaust aftertreatment system operating as designed (unrestricted). This test does not give pass or fail results. It only allows the user to validate Turbocharger 1 Turbine Outlet Pressure (TC1TOP) signal value under load. High TC1TOP will cause low Intake Manifold Pressure (IMP). Diagnose high TC1TOP concerns before diagnosing low IMP concerns.

1. Verify TC1TOP signal value is less than 5 psi (34 kPa) during Lug Down Test.

| Step | Action | Decision |
|---|---|---|
| | | No: Repair TC1TOP issue (See Electronic Control Systems Diagnostics in Engine Diagnostic Manual). After repairs are |

| | | complete, go to step 1 and recheck. |

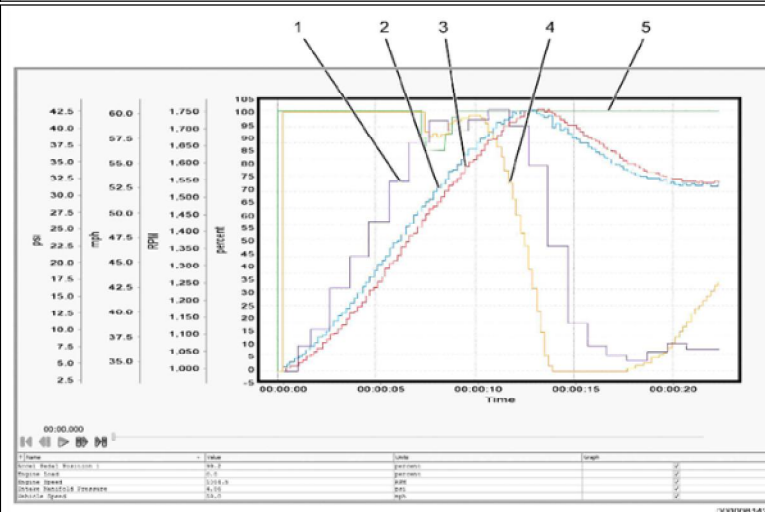
**Graph 5: Lug Down Test (Engine Speed, APP1, Vehicle Speed, and IMP)**

This graph shows the Intake Manifold Pressure (IMP) signal value responding as designed. This test does not give pass or fail results. It only allows the user to validate IMP signal value under load. Engine power band is typically between 1300 to 1700 rpm with peak power occurring around 1600 rpm. Anything outside of this power band drops boost and power significantly. Accelerator Pedal Position 1 (APP1) signal value must be 99.6% to successfully reach peak boost during this test. Low IMP can be the result of low Fuel Rail Pressure (FRP), or high Turbocharger 1 Turbine Outlet Pressure (TC1TOP). Diagnose low FRP concerns first, high TC1TOP concerns second, and low IMP concerns third.

| Step | Action | Decision |
|---|---|---|
| | | No: Diagnose and repair IMP issue (See Performance Diagnostics section in Engine Diagnostic Manual). After repairs are complete, go to step 1 and recheck. |
