Reference SSM71598

Models XJ / X351 XF / X250

Post K202 Transmission Control Switch Issues Rise and Title Fall.

Category Electrical

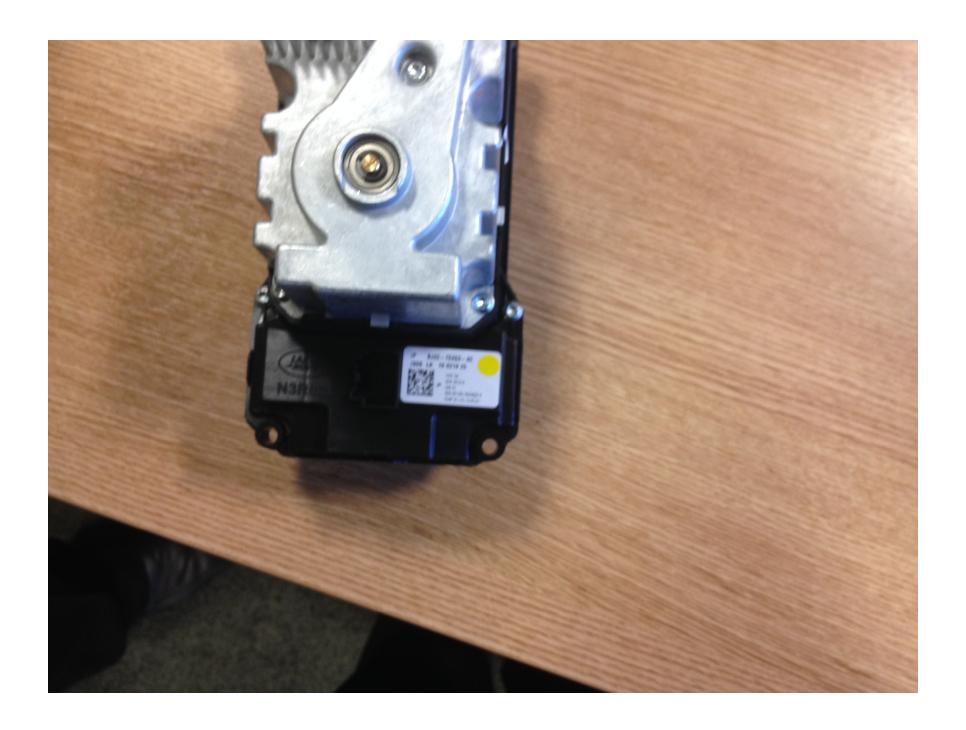
Please submit an ePQR detailing the failure mode, together with the session files and a picture of the TCS/GSM label as which is located at the right hand side of the connector, as shown in attached picture.

Once details have been attached to ePQR, then please proceed to replace GSM unit
