Reference SSM53217

Models XF / X250

Title XF Bumper to Headlamp Gap

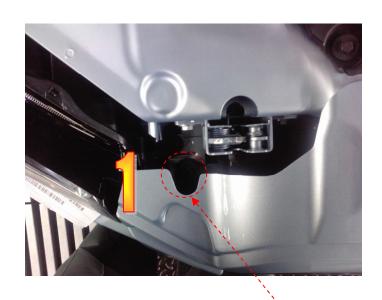
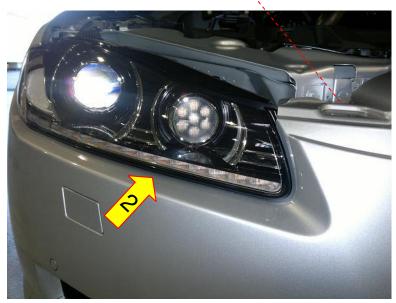
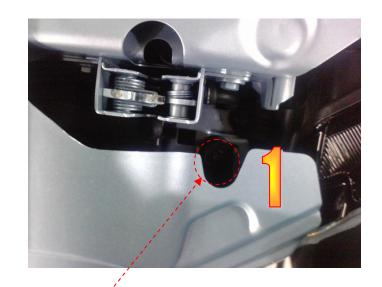
This is seen as a large gap between bumper and headlamp.

- 1. Locate 8mm bolt and loosen.
- 2. Apply pressure to the front of the bumper indicated by arrow 2 hold position and tighten bolt.
