Countries: CANADA, COLOMBIA, UNITED STATES, MEXICO, PUERTO RICO
Availability: ISIS, FleetISIS
Major System: CAB / SLEEPER / HOOD
Current Language: English
Other Languages: [Français](#), [Español](#)
Viewed: 886
Document ID: IK1600202
Revision: 1
Created: 11/13/2013
Last Modified: 8/8/2014
Author: Jeff McIntosh

Title: Cowl tray seal

Applies To: TerraStar, DuraStar, WorkStar, TranStar, ProStar, LoneStar, AE/AC Bus built before 11/11/2013

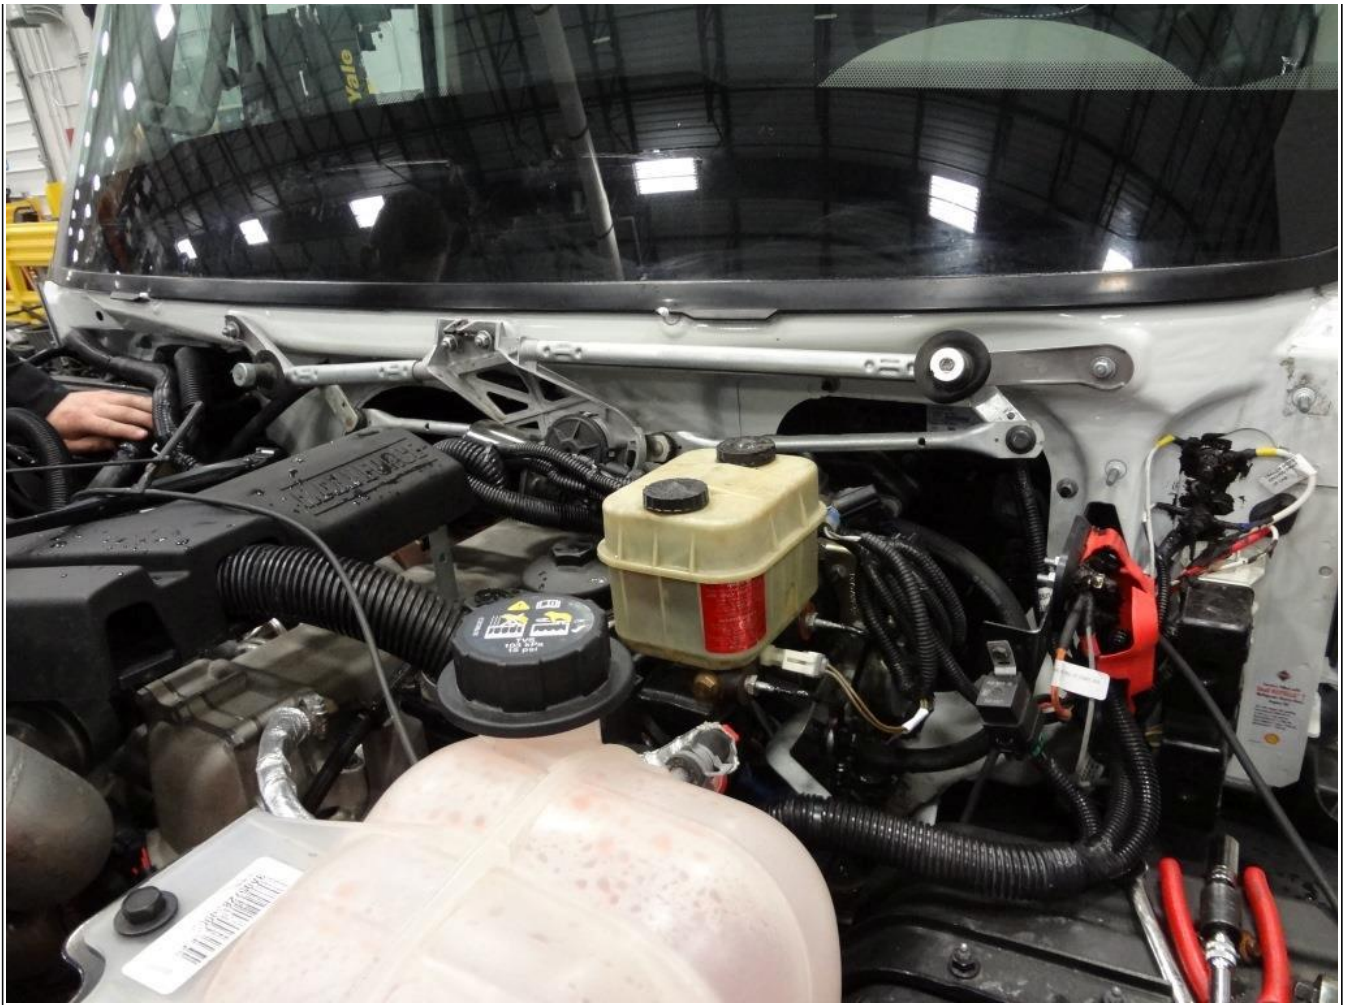
Prior to 11/11/2013, steel cab vehicles did not have a seal between the cowl tray and the cab. This allowed some of the water coming off the windshield to bypass the cowl tray and fall directly onto components in the engine compartment. The result was water entry into the cab through various connections on the cowl as well as decreased durability of components located underneath the cowl tray. Adding this seal will alleviate both of these concerns.

Cowl tray removed, no seal installed.
