**Document ID:** IK1600207

**Title:** Wind noise at upper side door

**Applies To:** All steel cabs: ProStar, LoneStar, TranStar, WorkStar, DuraStar, TerraStar

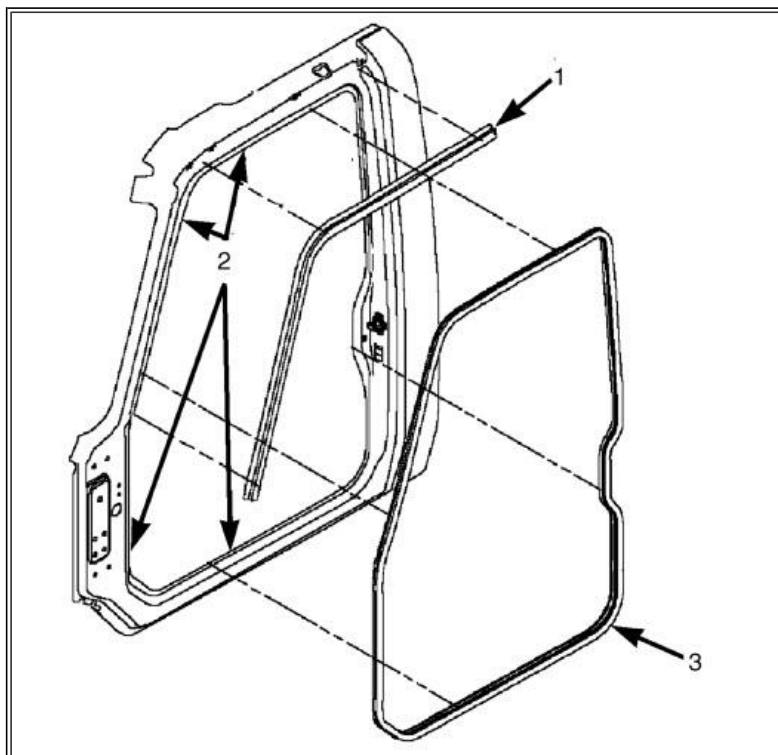
**Figure 1: Door Seals**

There are instances when the cab side entry door does not have proper contact with the door seals along the top of the door causing wind noise and/or flutter. In extreme cases and in inclement weather, there could be water intrusion as well. Many design improvements were made between 2004 and 2009 that drastically improved quality in this area, however there are still isolated occurrences when this issue still persists.

1. Inspect the primary (Figure 1, Item 3) and secondary (Figure 1, Item 1) door seals. Ensure they are seated down completely. If there is any visible damage or waves, adjust or replace as necessary.
2. Inspect the door to ensure proper positioning and flushness within the door frame. Refer to the specific cab service manual under "Adjustments: Cab Door" (general information), "Adjustments: Door Hinge" (affects door positioning), and "Adjustments: Striker Pin" (affects door flushness).

3. After replacing or adjusting any of the parts in steps 1 or 2, remove the primary door seal (Figure 1, Item 3).
4. While closing the door, place a dollar bill or similar size/shape piece of paper between the secondary door seal (Figure 1, Item 1) and the door (Not Shown) at the base of the A-pillar where the secondary door seal starts/terminates just above the upper door hinge (Figure 2, Item 1).

5. Slide the dollar bill up and along the door all the way back to the upper rear corner of the door.
6. If the dollar bill does not slide freely, there is proper contact between the door and seal and no shimming is required. Reinstall the primary door seal (Figure 1, Item 3), ensuring that it is completely seated all the way around the door perimeter. The job is complete.
