# Thor Motor Coach Technical Information Bulletin

## TIB # 14-003

Issue: On certain 2014 Tuscany 44MT units, the tile was not run far enough towards the edge of the floor at the front of the driver's side slide out. This may cause the slide roller to fall off of the edge tile when the room is fully extended. This may lead to damage to the tile and/or slide roller.

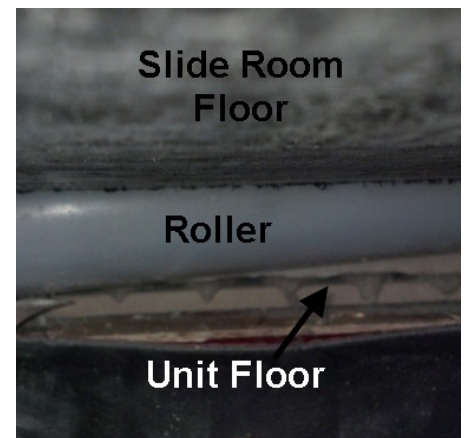
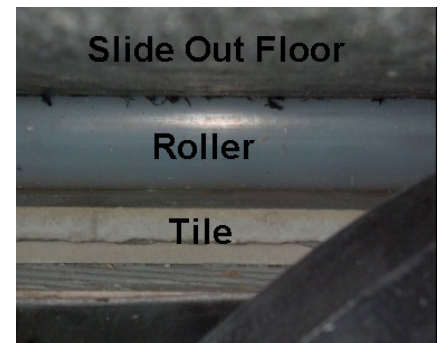
Photo to the right shows the roller falling off the edge of the tile before any repair work is done

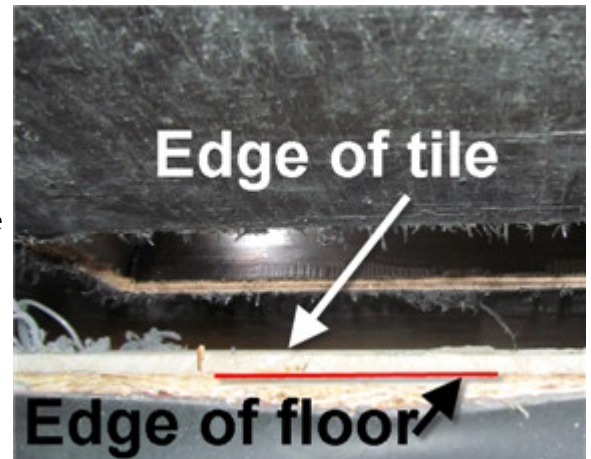
Measure the gap between the edge of the floor at the side wall and where the tile begins. If this measurement is more than 1", proceed with the repair. If the measurement is less than 1", this repair is not needed.

Clean out any grout or debris in the area of the gap.

Dry fit the plywood so that it butts up against the existing tile.

Trim the plywood if needed and dry fit again.

Once the plywood is the correct size, dry fit the brackets on the plywood. The brackets should sit so that the lower leg of the brackets is flush with the side-wall of the unit. Mark the position of the brackets on the plywood.
