Subject: FRONT SEAT BACK TRIM - FRAYED / POOR APPEARANCE - (CLOTH SEAT ONLY)	Bulletin No: 09-008/14
	Last Issued: 01/24/2014

2013-2014 CX-5 vehicles equipped with cloth seats

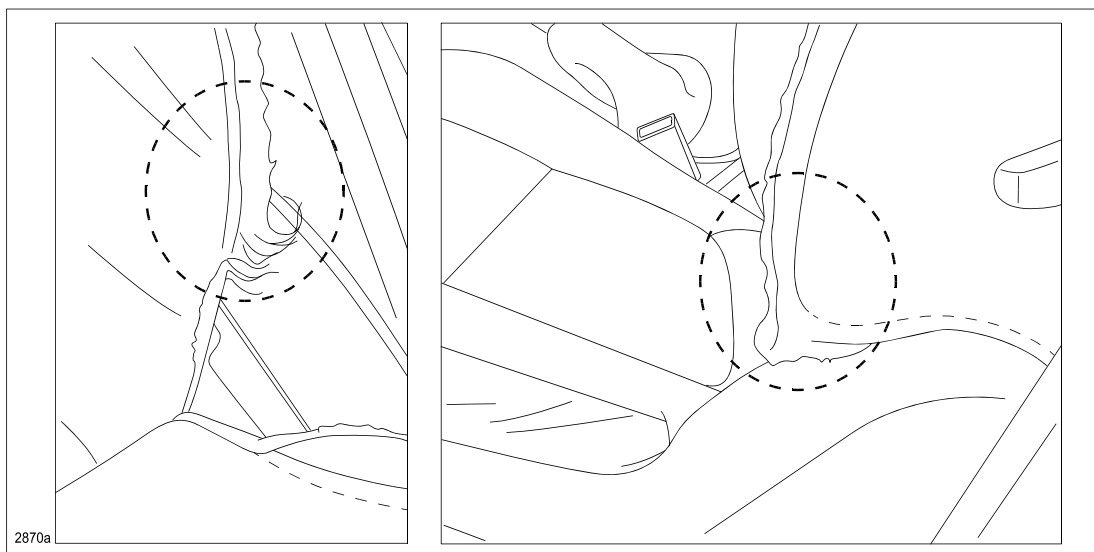
Some vehicles may exhibit a frayed front seat back trim, which causes a poor appearance concern.

This may occur under special conditions where the customer rubs against the seat back trim when entering or exiting the vehicle. If the customer wears clothes designed with metal accessories (i.e. jewelry, tack, zipper or Velcro), the damage may occur.

1. Verify the customer concern.
2. Replace the affected seat back trim(s) with a newly established service part according to the instructions on MS3 online or the Workshop Manual (section 09-13 FRONT SEAT BACK TRIM REMOVAL/INSTALLATION).
3. Verify the repair.
