Subject: MASTER WARNING LIGHT IS ON AND INSTRUMENT CLUSTER WARNING MESSAGE IS DISPLAYED (DTC P1794 AND P2502)	Bulletin No: 01-001/14 Last Issued: 01/24/2014
--	---

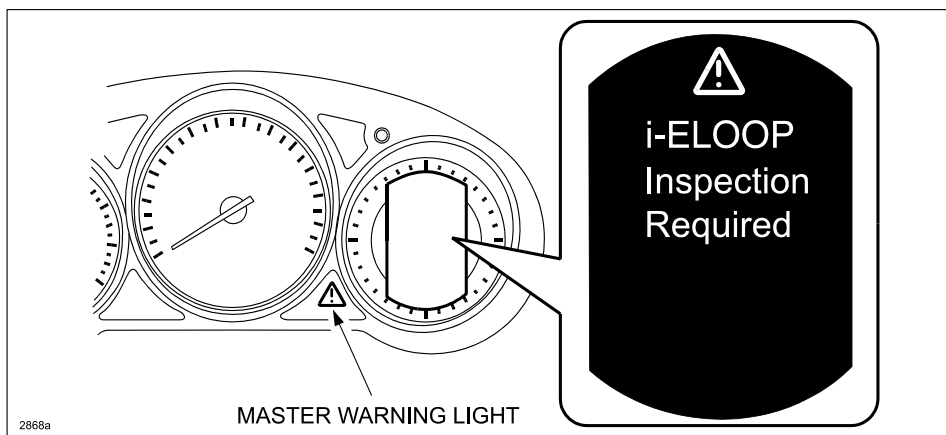
- Warning message "i-ELOOP Inspection Required" is displayed in the instrument cluster information display while driving.
- The Master warning light will be illuminated.

- DTC P1794:00 (Capacitor (i-ELOOP) system: Capacitor (i-ELOOP) malfunction) will be stored in PCM memory.

Customers having this concern should have their vehicle repaired using A. REPAIR PROCEDURE.

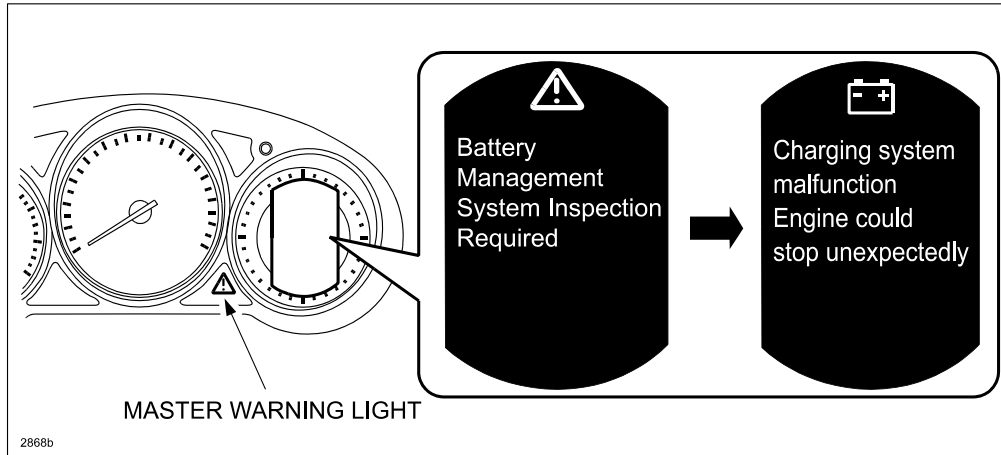
- a. Warning message "Battery Management System Inspection Required" and then "Charging System Malfunction/Engine could stop unexpectedly" is displayed in the instrument cluster information display after driving in the rain.
- b. The Master warning light will be illuminated. **The Mazda6 warning indicator light and warning messages are shown below:**

- c. The following DTCs are stored in PCM memory:
 - DTC P1794:00 - Capacitor (i-ELOOP) system: Capacitor (i-ELOOP) malfunction
 - DTC P2502:00 - Generator system: Malfunction in voltage generated by generator

Customers having this concern should have their vehicle repaired using B. REPAIR PROCEDURE.
