Subject: VARIOUS ELECTRICAL SYSTEM MALFUNCTION(S) RELATED TO C-15 CONNECTOR CORROSION	Bulletin No: 09-005/14
	Last Issued: 01/14/2014

2013-2014 CX-5 vehicles with VINs lower than JM3KE*****365953 (produced before June 25, 2013)

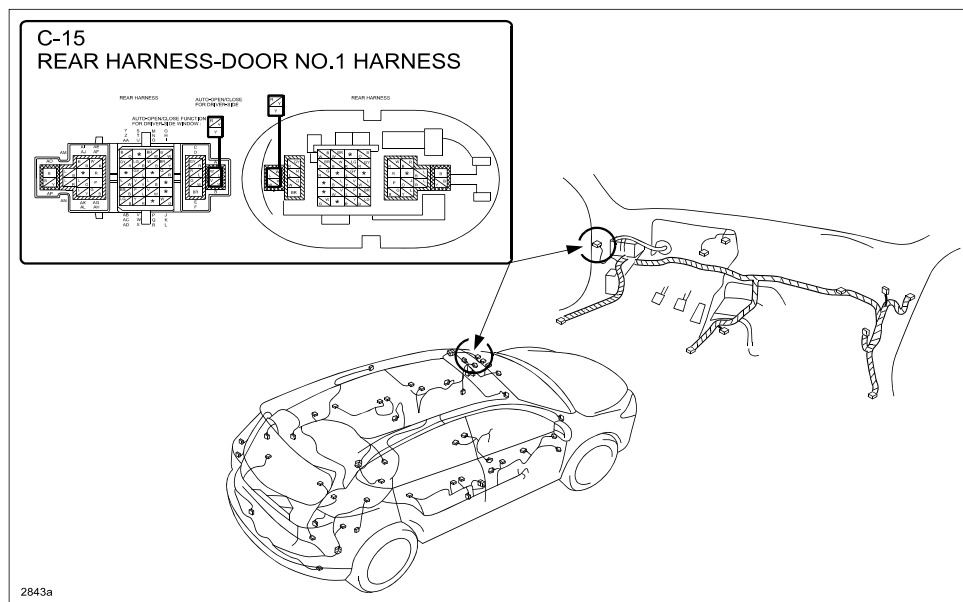
- The driver side power window does not operate.
- The door does not open when using the advanced keyless system.
- The warning lamp stays ON even after the ignition switch is turned OFF.

The symptoms listed above may be caused by corrosion of the C-15 connector terminals due to water intrusion through the front door. In low ambient temperatures, the door harness hardens. If the door is fully opened, it may create a gap between the door and the door harness grommet, which may allow water to enter through the gap.

- The front door harness grommet has been changed to improve sealing performance.
- Holes inside the front pillar (which are made for weight reduction), have been covered to prevent water intrusion.

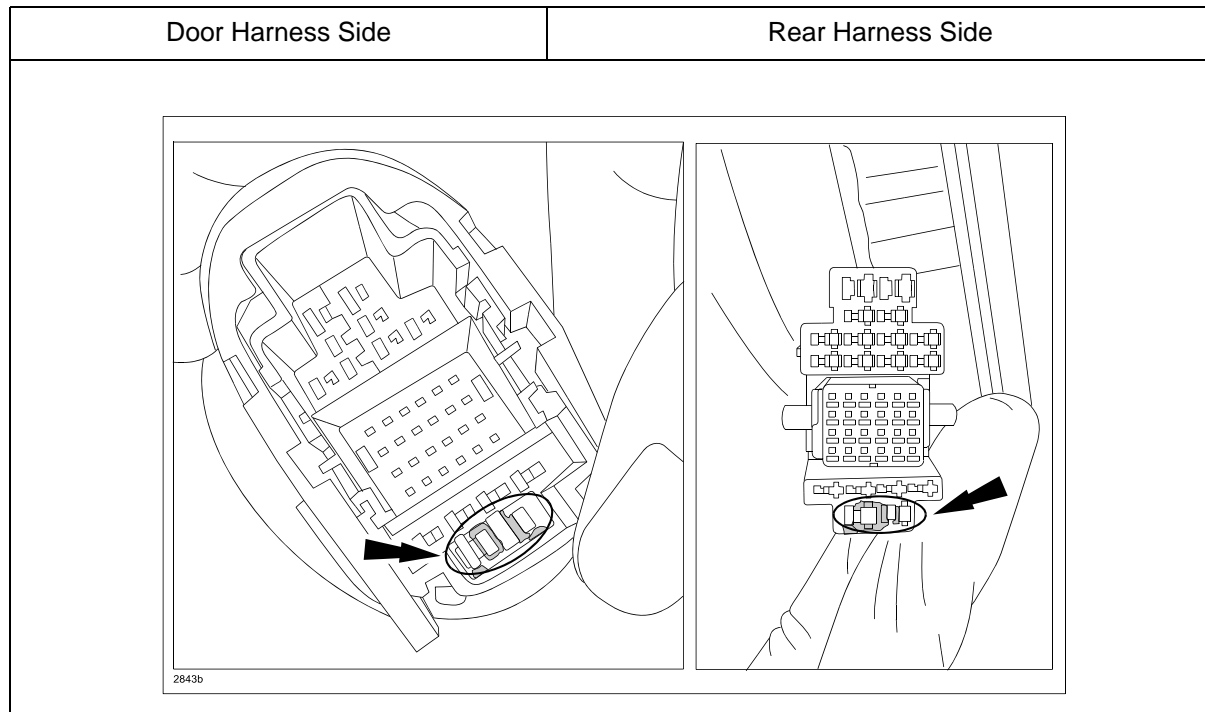
- If there is any corrosion at the C-15 connector, replace the door harness and repair the rear harness according to the following repair procedure.
 - If there is no corrosion found at the C-15 connector, this bulletin is not applicable. Troubleshoot the concern(s) according to the MS3 online instructions or the Workshop Manual.
1. Verify the customer concern.
 2. Record customers pre-set radio stations.
 3. Slide the driver side front seat fully backwards.
 4. Disconnect the negative battery cable.
 5. Disconnect the C-15 connector according to the MS3 online instructions or the Workshop Manual (section 09-11 FRONT DOOR REMOVAL/INSTALLATION).
 6. Inspect for any corrosion found on the terminals shown below.

- If there is any corrosion found on the terminals, go to next step.
 - If there is no corrosion found on the terminals, this bulletin is not applicable. Troubleshoot the concern(s) according to the MS3 online instructions or the Workshop Manual.
7. Remove the driver-side front side trim according to the MS3 online instructions or the Workshop Manual (section 09-17 FRONT SIDE TRIM REMOVAL/INSTALLATION).
 8. Remove the hood release lever from the under panel according to the MS3 online instructions or the Workshop Manual (section 09-14 HOOD LATCH AND RELEASE LEVER REMOVAL/INSTALLATION).
