<b>Subject:</b>  STAINS FOUND ON PAINT DURING PDI	<b>Bulletin No:</b> 09-004/14
	<b>Last Issued:</b> 01/14/2014

## BULLETIN NOTE

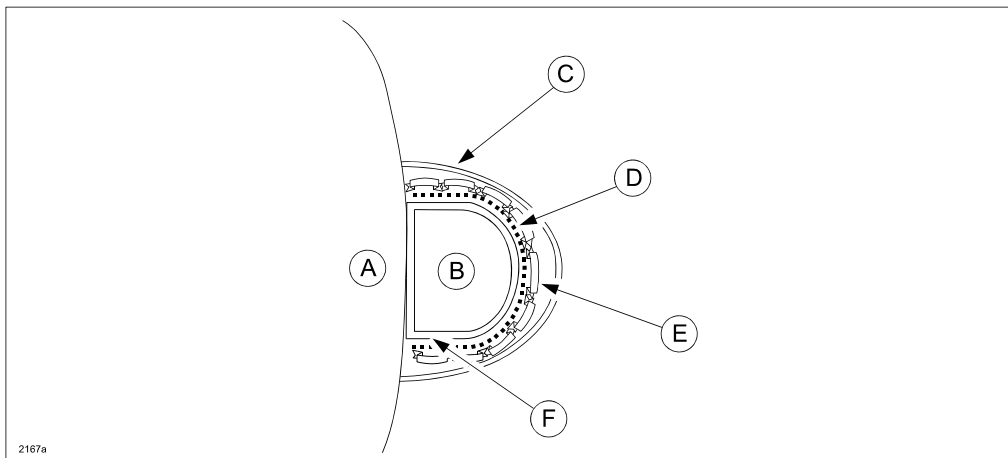
A - Body Panel

B - Molding

C - Aluminum foil covering all area

D - Wet towel

E - Folded aluminum foil

F - Aluminum foil tape

1. Visually inspect the top coat surface for stains.
  - If stains are found, use a heat gun (for smaller stains) or an infrared drier (for larger stains) to heat the affected area and remove the stains.
2. Insulate all plastic and rubber parts (as shown below) using heat insulation materials (C ~ F) prior to beginning the application of heat.

- Since this repair procedure requires the use of heat from a heat gun or infrared drier, be sure to insulate all rubber or plastic parts which are easily affected by heat from near the affected stain area.
- Use extreme care to ensure the top coat surface temperature stays below 284°F (140°C).
- To protect materials inside the cabin area (i.e. carpet, seats, etc.), also place insulation over the glass as necessary.
