<b>Subject:</b> MASTER WARNING LIGHT IS ON AND INSTRUMENT CLUSTER WARNING MESSAGE IS DISPLAYED (DTC P1794 AND P2502)	<b>Bulletin No:</b> 01-001/14
	<b>Last Issued:</b> 01/10/2014

2014-2015 Mazda6

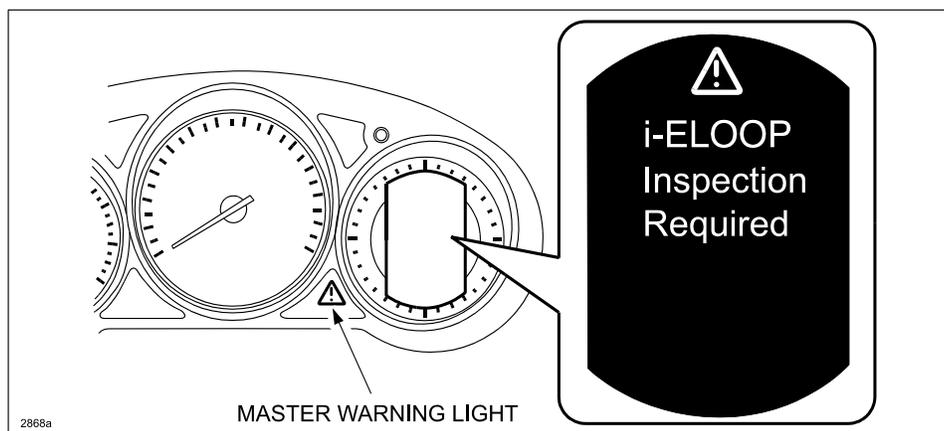
- a. Warning message “i-ELOOP Inspection Required” is displayed in the instrument cluster information display while driving.
- b. The Master warning light will be illuminated.

- c. DTC P1794:00 (Capacitor (i-ELOOP) system: Capacitor (i-ELOOP) malfunction) will be stored in PCM memory.

Customers having this concern should have their vehicle repaired using A. REPAIR PROCEDURE.

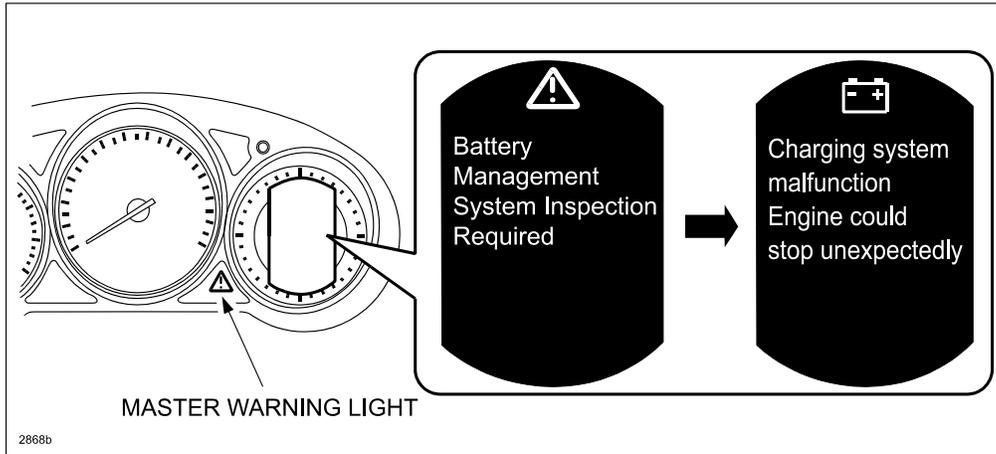
- a. Warning message “Battery Management System Inspection Required” and then "Charging System Malfunction/Engine could stop unexpectedly” is displayed in the instrument cluster information display after driving in the rain.
- b. The Master warning light will be illuminated.

- c. The following DTCs are stored in PCM memory:
  - DTC P1794:00 - Capacitor (i-ELOOP) system: Capacitor (i-ELOOP) malfunction
  - DTC P2502:00 - Generator system: Malfunction in voltage generated by generator

Customers having this concern should have their vehicle repaired using B. REPAIR PROCEDURE.
