<b>Subject:</b>  RATTLE NOISE FROM BOTTOM OF A-PILLAR	<b>Bulletin No:</b> 09-001/14
	<b>Last Issued:</b> 01/08/2014

2014 Mazda3 with VINS lower than JM1BM\*\*\*\*\*154277 (produced before December 1, 2013)

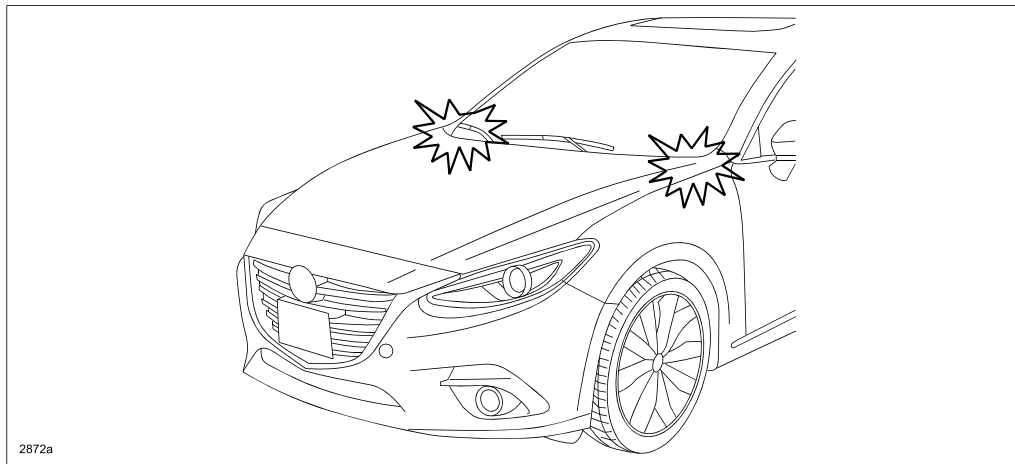
Some vehicles may exhibit a rattle noise from the bottom of the A-pillar when driving on rough roads or over bumps. This is caused by the cowl upper plate and/or dash upper panel interfering with the wiper bracket. To correct the problem, the shape of the wiper bracket has been changed. For the affected vehicles, a clearance needs to be created between the wiper bracket and cowl upper plate and between the wiper bracket and dash upper panel.
