Subject: RATTLE NOISE FROM INSTRUMENT PANEL AND/OR CREAK NOISE FROM A-PILLAR OVER ROUGH / BUMPY ROADS	Bulletin No: 09-002/14
	Last Issued: 01/08/2014

2013-2014 CX-5

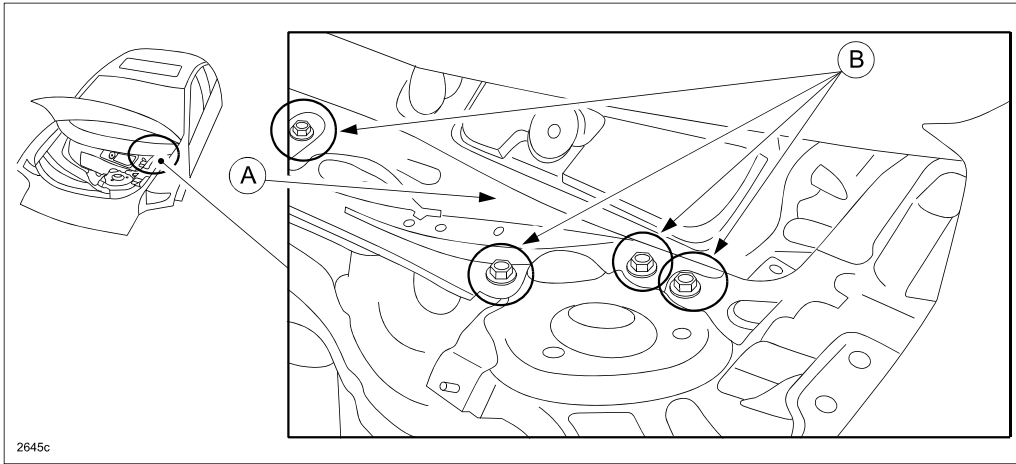
The rattle noise may be caused by low cowl panel (A) mounting bolt (B) torque.

2. Retighten all ten (10) cowl panel bolts (A) to:
Tightening Torque: 17-22 ft. lbs {22-30 Nm, 2.3-3.0 kgf-m}
3. Reinstall the cowl grille according to the online MS3 instructions or the Workshop Manual (section 09-16 COWL GRILLE REMOVAL/INSTALLATION).

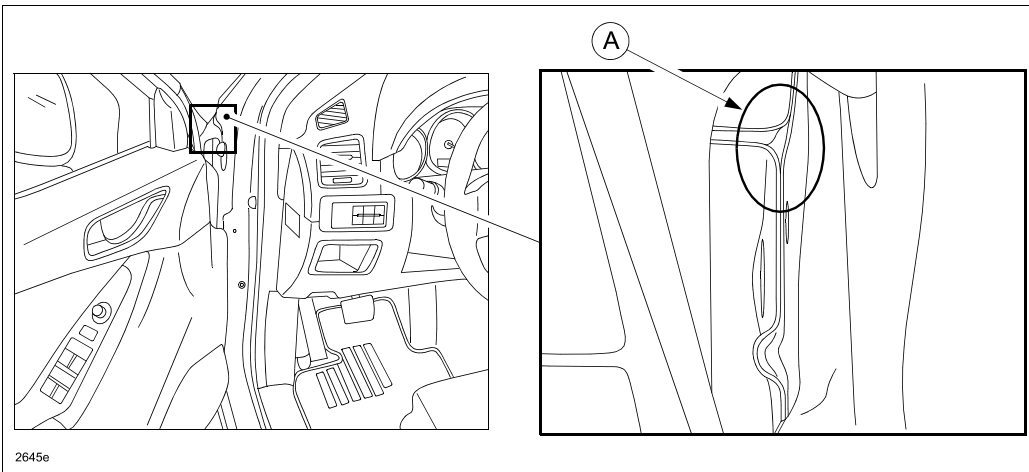
This noise may be caused by two joined panels (A) scraping together at the A-pillar. The panel weld areas have been improved during the mass-production of vehicles with VINs JM3KE*****128359 (produced June 1, 2012) or higher.

Enlarge the clearance between two (2) panels (A) using an appropriate tool (i.e. flat-blade screwdriver).
