Service Bulletin

RATTLE NOISE FROM REAR BRAKE CALIPER

Bulletin No: 04-001/14	Last Issued: 1/8/2014
© 2014 Mazda Motor of America, Inc.

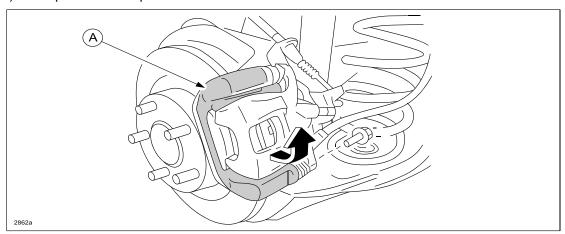
A rattle noise may be heard from the rear part of the vehicle when driving on rough roads. If the driver puts his/her foot on the brake pedal, the noise disappears. The rear brake pad(s) may be moving inside the caliper(s), causing a rattling noise.

- 1. Verify customer concern.
- 2. When noise is present, lightly depress the brake pedal. Does the noise disappear?
 - a. Yes Proceed to Step 3.
 - b. No This bulletin does not apply. Proceed to step 4.
- 3. Replace the rear brake caliper mounting support (A) and brake pad shim and retainer at the affected side. Refer to MS3 online or Workshop Manual (section 04-11 REAR BRAKE (DISC) REMOVAL/INSTALLATION). Then proceed to step 5.
