Subject: HOOD VIBRATION ABOVE 68 MPH	Bulletin No: 09-015/14
	Last Issued: 02/25/2014

2014 Mazda6 vehicles with VINs lower than JM1 GJ ***** 162912 (produced before December 03, 2013)

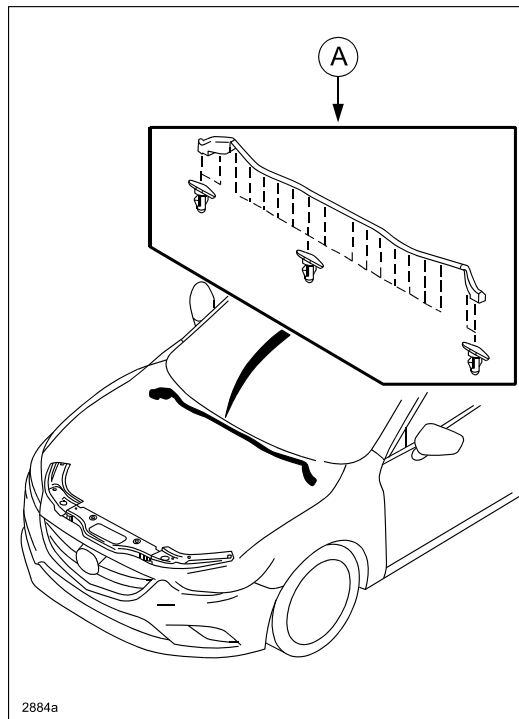
Some vehicles may exhibit a hood vibration when driving above 68 mph (110Km/h). This may be caused by a cowl grill that is not firmly attached.

1. Verify customer concern.
2. Replace the cowl grill seal (A). Refer to MS3 online or Workshop Manual (section 09-16 COWL GRILLE REMOVAL/INSTALLATION).

NOTE: The cowl grill seal is attached to the cowl grill with clips.
