RUST ON BOTTOM OF REAR DOOR GLASS GUIDE

Bulletin No: 09-014/14**Last Issued:** 02/25/2014**BULLETIN NOTE**

2010-2013 Mazda3 (including Mazdaspeed3)

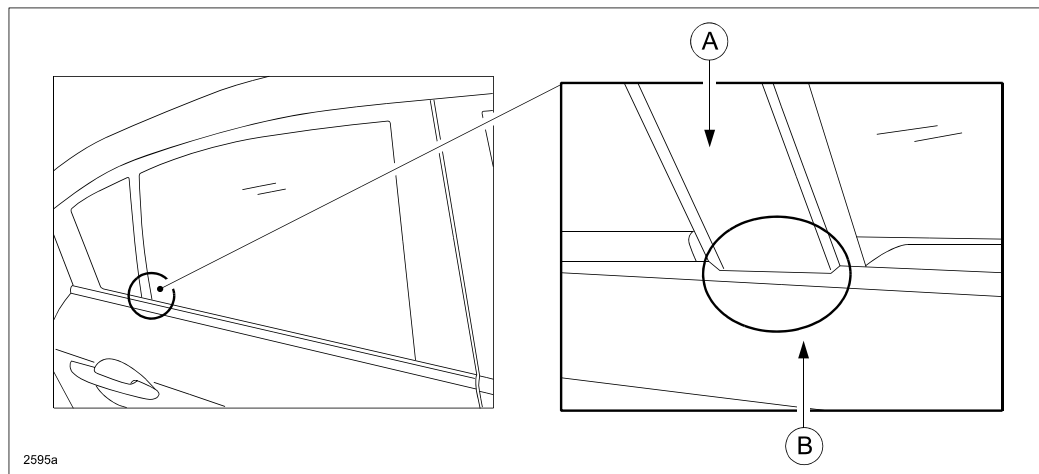
Some vehicles may exhibit rust on the bottom of the rear door glass guide (A) from contact with the rear beltline molding (B). This is caused by a vibration while driving.

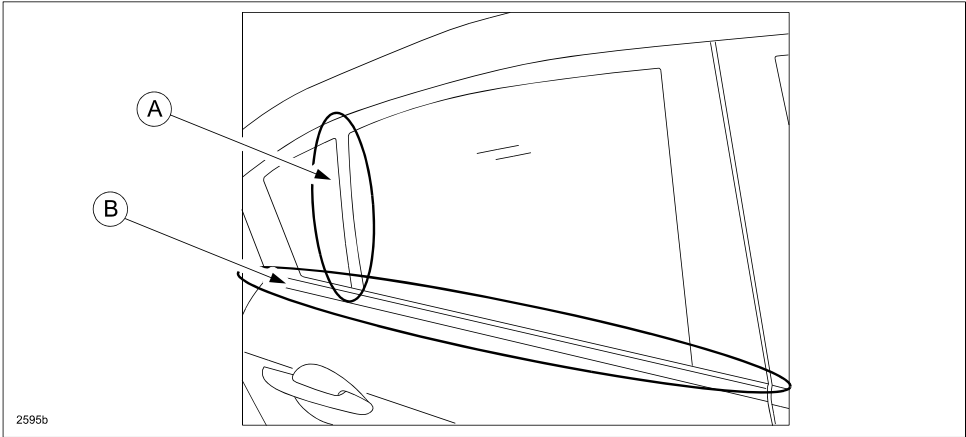
A: Rear door glass guide

B: Rear beltline molding

At the affected side(s), replace both the the rear door glass guide assembly and the rear beltline molding with modified ones. Refer to MS3 online instructions or Workshop Manual section 09-12 REAR DOOR QUARTER GLASS REMOVAL/INSTALLATION and 09-16 REAR BELTLINE MOLDING REMOVAL/INSTALLATION.

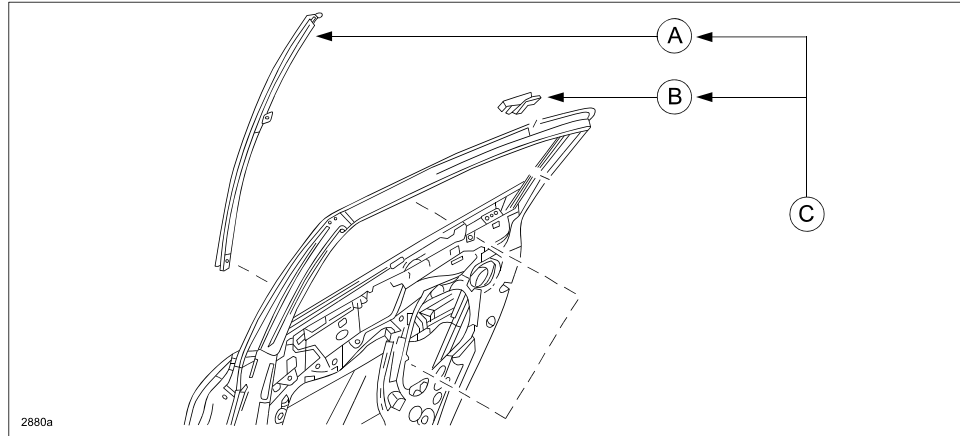
A: Rear door glass guide (film is attached)

B: Protector (current part)

C: Rear door glass guide assembly (service part)

At the affected side(s), replace the rear door glass guide assembly (C) with a modified one. Refer to MS3 online instructions or Workshop Manual section 09-12 REAR DOOR QUARTER GLASS REMOVAL/INSTALLATION.
