© 2014 Mazda Motor of America, Inc.

<b>Subject:</b> <b>MASTER WARNING LIGHT IS ON AND INSTRUMENT CLUSTER WARNING MESSAGE IS DISPLAYED (DTC P1794 AND P2502)</b>	<b>Bulletin No:</b> 01-001/14
	<b>Last Issued:</b> 02/25/2014

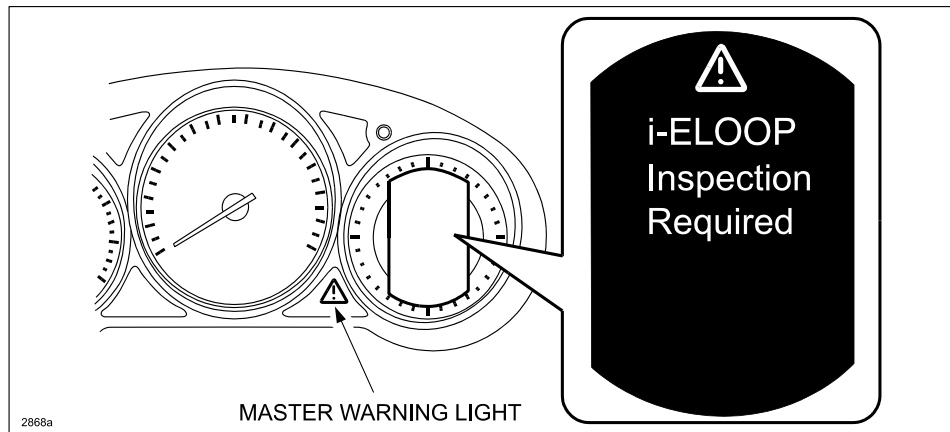
- Warning message “i-ELOOP Inspection Required” is displayed in the instrument cluster information display while driving.
- The Master warning light will be illuminated.

- DTC P1794:00 (Capacitor (i-ELOOP) system: Capacitor (i-ELOOP) malfunction) will be stored in PCM memory.

Customers having this concern should have their vehicle repaired using A. REPAIR PROCEDURE.

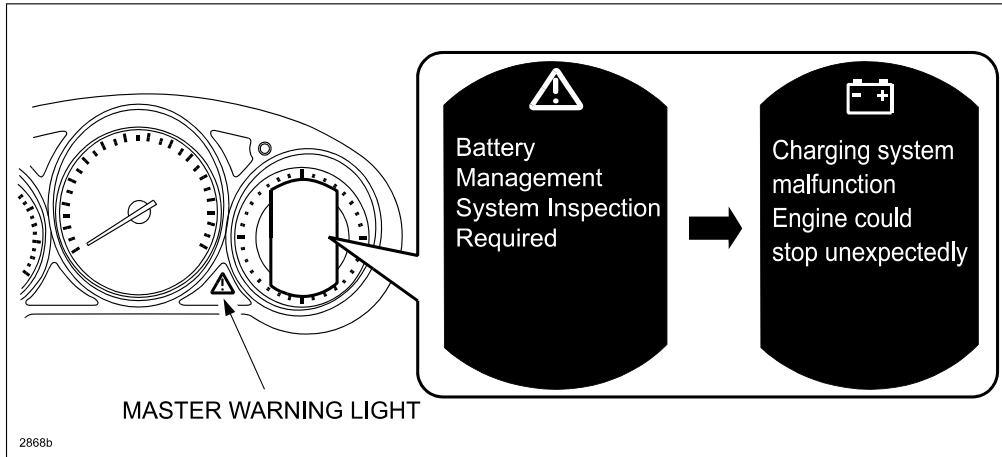
- a. Warning message “Battery Management System Inspection Required” and then "Charging System Malfunction/Engine could stop unexpectedly" is displayed in the instrument cluster information display after driving in the rain.
- b. The Master warning light will be illuminated. **The Mazda6 warning indicator light and warning messages are shown below:**

- c. The following DTCs are stored in PCM memory:
  - DTC P1794:00 - Capacitor (i-ELOOP) system: Capacitor (i-ELOOP) malfunction
  - DTC P2502:00 - Generator system: Malfunction in voltage generated by generator

Customers having this concern should have their vehicle repaired using B. REPAIR PROCEDURE.
