© 2014 Mazda Motor of America, Inc.

Subject: VARIOUS ELECTRICAL SYSTEM MALFUNCTION(S) RELATED TO C-15 CONNECTOR CORROSION	Bulletin No: 09-005/14
	Last Issued: 02/07/2014

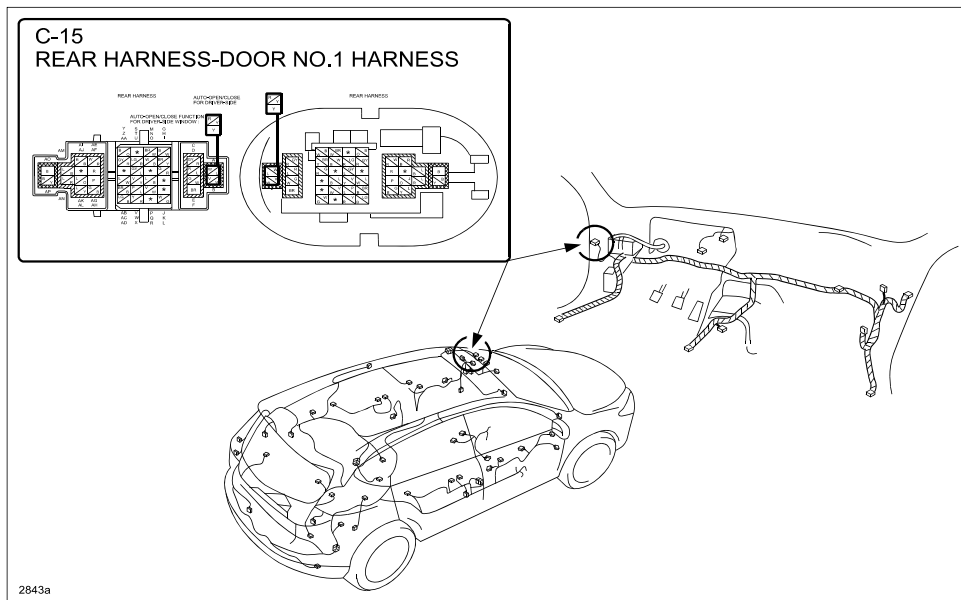
Some vehicles may experience one or more of the following symptoms in connection with a malfunction related to the C-15 connector.

- The driver side power window does not operate.
- The door does not open when using the advanced keyless system.
- The warning lamp stays ON even after the ignition switch is turned OFF.

The symptoms listed above may be caused by corrosion of the C-15 connector terminals due to water intrusion through the front door. In low ambient temperatures, the door harness hardens. If the door is fully opened, it may create a gap between the door and the door harness grommet, which may allow water to enter through the gap.

- The front door harness grommet has been changed to improve sealing performance.
- Holes inside the front pillar (which are made for weight reduction), have been covered to prevent water intrusion.

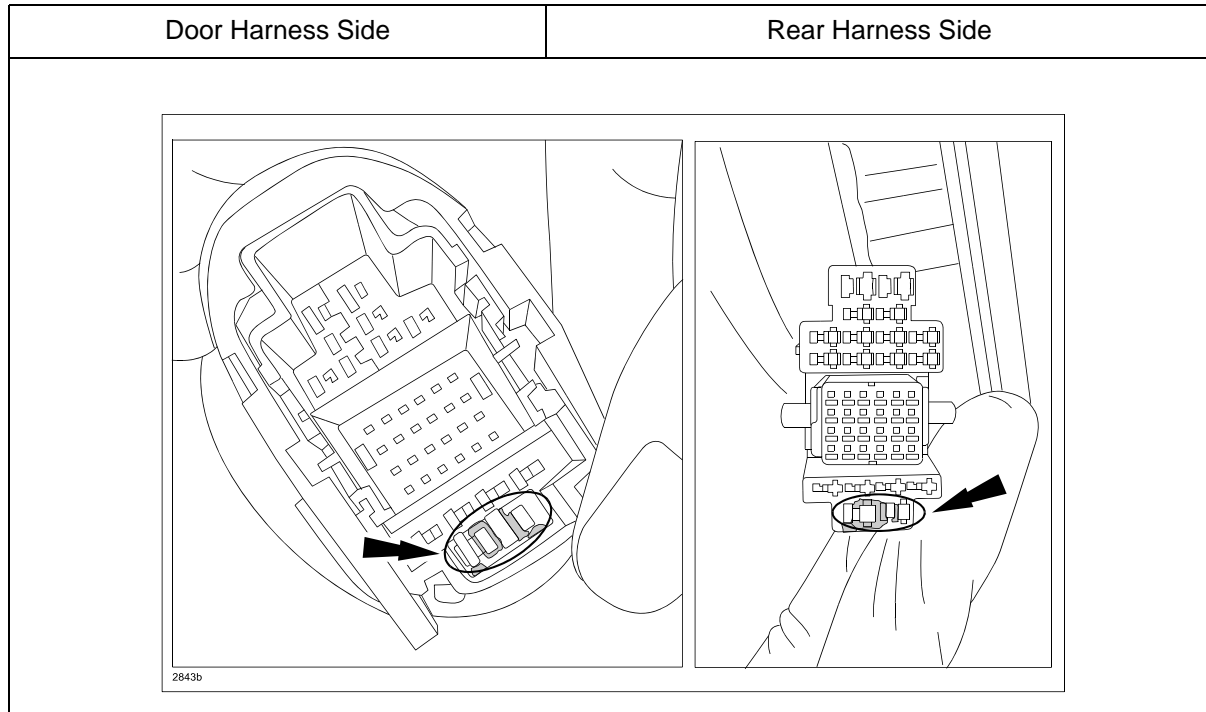
- If there is any corrosion at the C-15 connector, replace the door harness and repair the rear harness according to the following repair procedure.
 - If there is no corrosion found at the C-15 connector, this bulletin is not applicable. Troubleshoot the concern(s) according to the MS3 online instructions or the Workshop Manual.
1. Verify the customer concern.
 2. Record customers pre-set radio stations.
 3. Slide the driver side front seat fully backwards.
 4. Disconnect the negative battery cable.
 5. Disconnect the C-15 connector according to the MS3 online instructions or the Workshop Manual (section 09-11 FRONT DOOR REMOVAL/INSTALLATION).
 6. Inspect for any corrosion found on the terminals shown below.

- If there is any corrosion found on the terminals, go to next step.
 - If there is no corrosion found on the terminals, this bulletin is not applicable. Troubleshoot the concern(s) according to the MS3 online instructions or the Workshop Manual.
7. Remove the driver-side front side trim according to the MS3 online instructions or the Workshop Manual (section 09-17 FRONT SIDE TRIM REMOVAL/INSTALLATION).
 8. Remove the hood release lever from the under panel according to the MS3 online instructions or the Workshop Manual (section 09-14 HOOD LATCH AND RELEASE LEVER REMOVAL/INSTALLATION).
