Subject: MASTER WARNING LIGHT IS ON AND INSTRUMENT CLUSTER WARNING MESSAGE IS DISPLAYED (DTC P1794 AND P2502)	Bulletin No: 01-001/14
	Last Issued: 02/04/2014

2014-2015 Mazda6 vehicles with VINs lower than JM1 GJ ***** 162912 (produced before December 3, 2013)

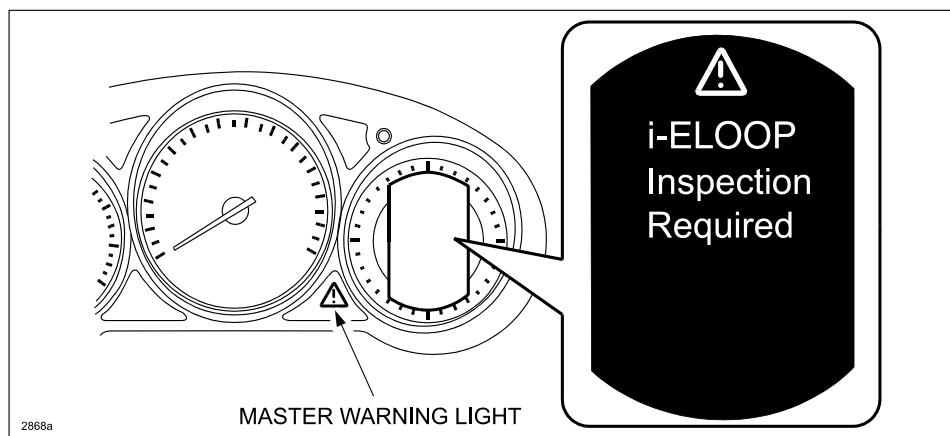
- Warning message “i-ELOOP Inspection Required” is displayed in the instrument cluster information display while driving.
- The Master warning light will be illuminated.

- DTC P1794:00 (Capacitor (i-ELOOP) system: Capacitor (i-ELOOP) malfunction) will be stored in PCM memory.

Customers having this concern should have their vehicle repaired using A. REPAIR PROCEDURE.

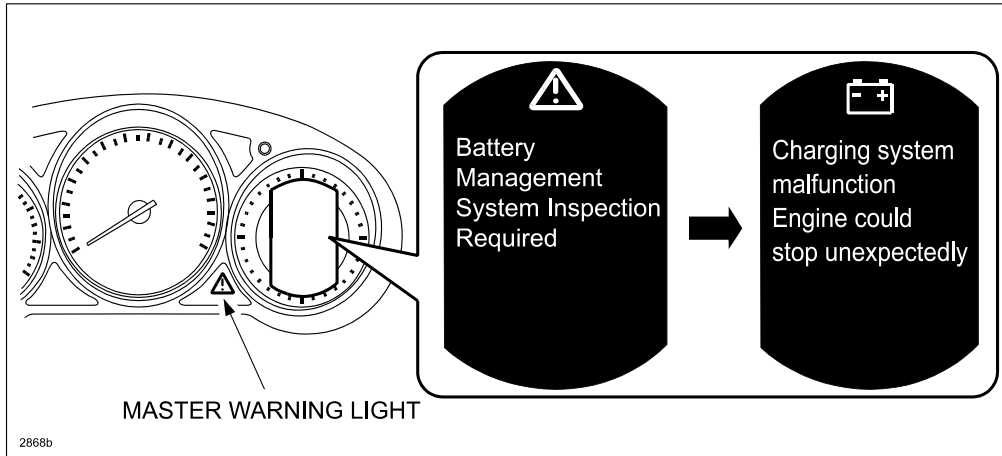
- a. Warning message “Battery Management System Inspection Required” and then "Charging System Malfunction/Engine could stop unexpectedly" is displayed in the instrument cluster information display after driving in the rain.
- b. The Master warning light will be illuminated.

- c. The following DTCs are stored in PCM memory:
 - DTC P1794:00 - Capacitor (i-ELOOP) system: Capacitor (i-ELOOP) malfunction
 - DTC P2502:00 - Generator system: Malfunction in voltage generated by generator

Customers having this concern should have their vehicle repaired using B. REPAIR PROCEDURE.
