<b>Subject:</b>  <b>WHINING NOISE FROM AUTOMATIC TRANSAXLE</b>	<b>Bulletin No:</b> 05-004/14
	<b>Last Issued:</b> 03/19/2014

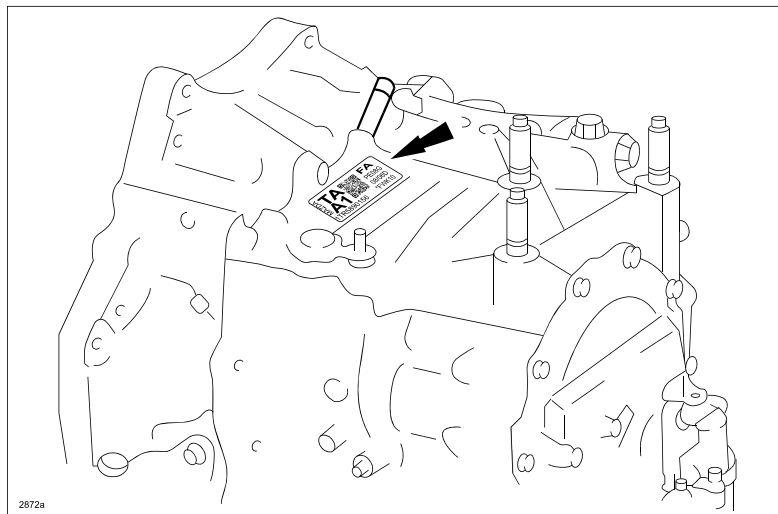
This is caused by a damaged bearing in the transaxle due to improper configuration of the transaxle case. A modification has now been implemented on automatic transaxles with the serial number TR1111680 and higher or TD1104906 and higher. The serial number can be found on top of the transaxle case near the manual shaft lever.

1. Verify customer concern.
2. Replace the 6AT assembly with a new one according to MS3 online instructions or Workshop Manual section 05-17.
3. Verify repair.
